MRI Safety 10 Years Later

What can we learn from the accident that killed Michael Colombini?

By Tobias Gilk, M.Arch. HSDQ, and Robert J. Latino

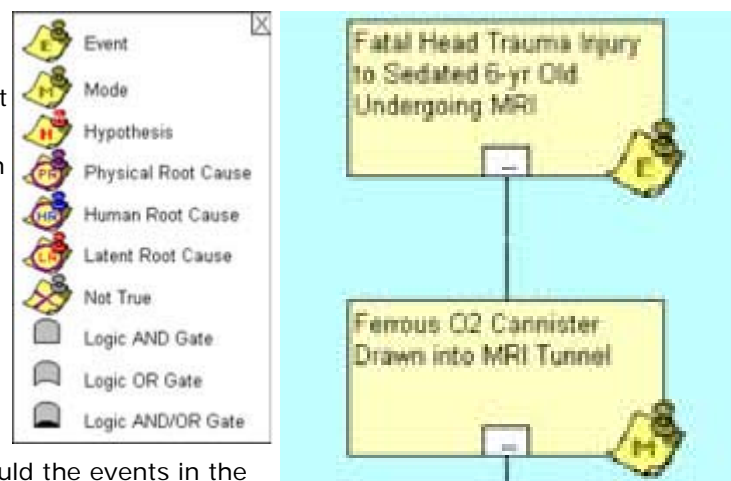
Figure 1: Colombini Logic Tree Event and Mode

Our logic tree starts with an Event (E). The Event is the last effect in a chain of cause-and-effect relationships. The Event is a fact. At this point we ask "How did the event occur?" The answer is labeled M for 'Mode.' (Figure 1).

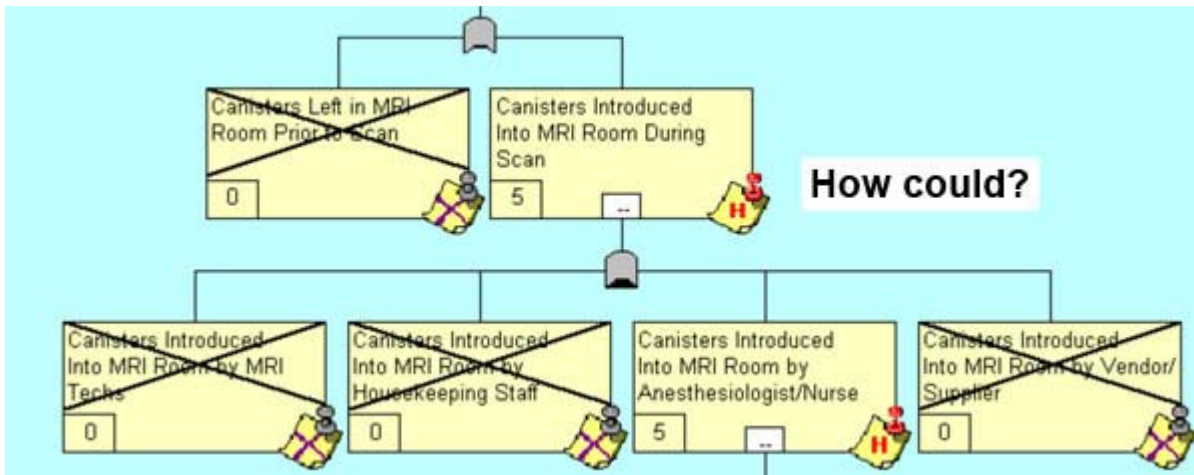
Figure 2: 'How Could' Questioning Process

By asking, "How could the ferrous O2 canister have been drawn into the MRI tunnel?" we hypothesize that either the canisters were left in the MRI room prior to the scan or the canisters were introduced into the MRI room during the scan (Figure 2).

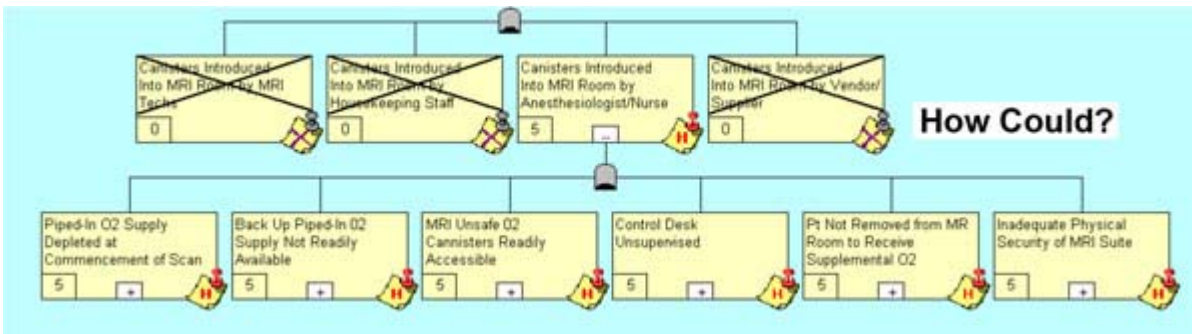
Figure 4: The Next Level of 'How Could' Questioning

So the questioning and validation process continues as we progress backwards in time and re-create the path of failure. In Figure 4, we show the next level of questioning and the resulting six paths of simultaneous contribution to the overall incident.

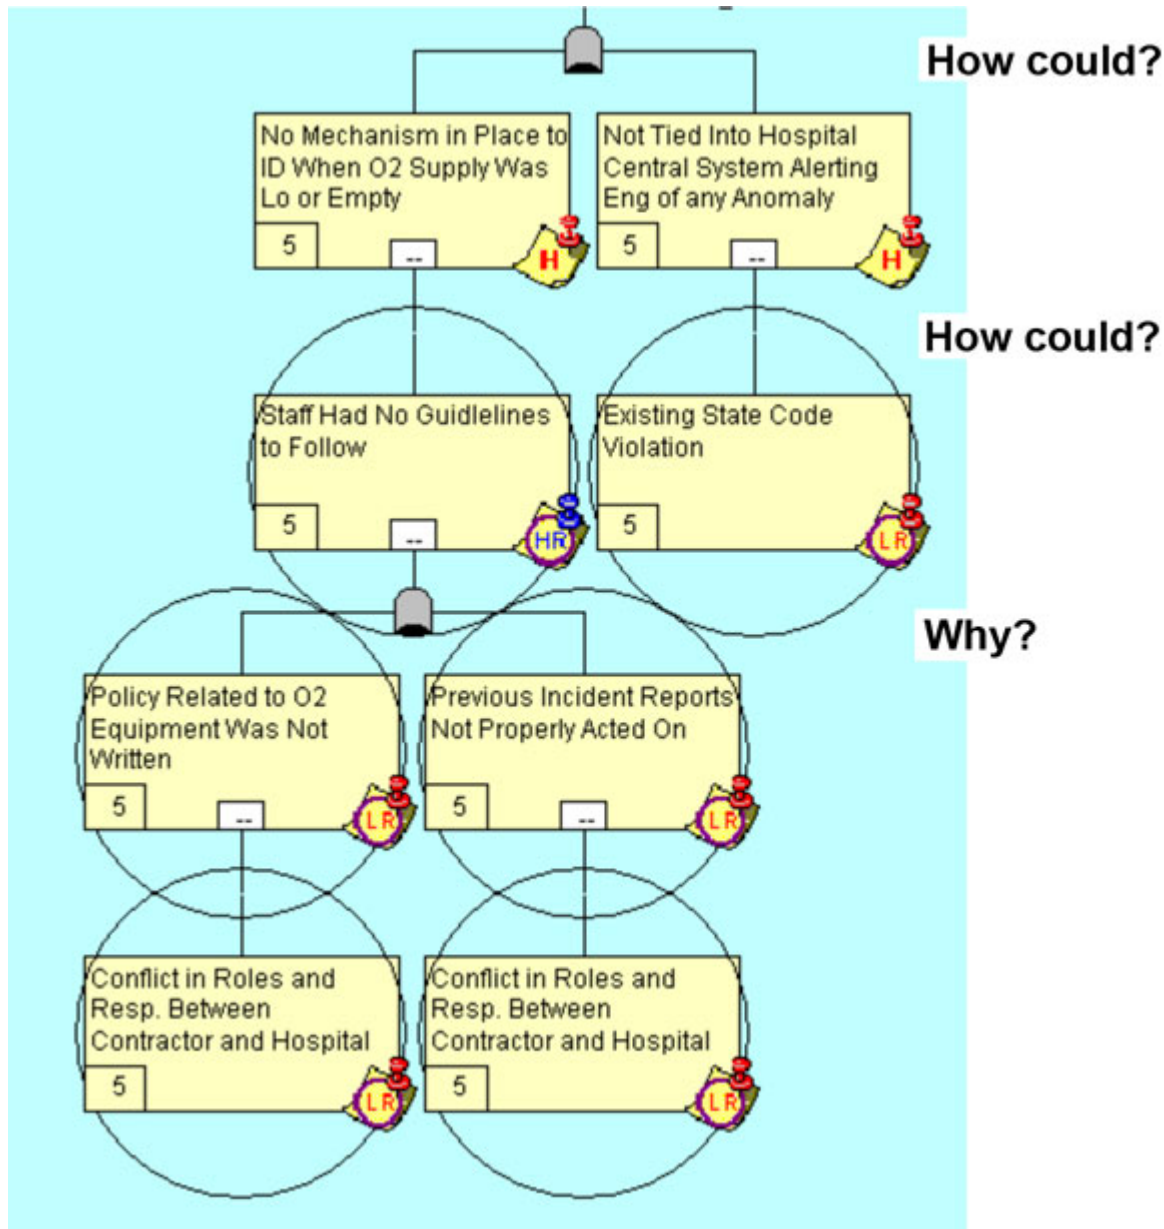
Figure 5: The Uncovering of Latent Root Causes

As this questioning process continues, we drill past the symptoms and deeper into the systemic issues that really triggered poor decision-making. By following the "Piped-In O2 Supply Depleted at Commencement of Scan" box we can conclude the string of logic depicted in Figure 5.

When we get to a point on our logic tree where a decision has been made (Human Root [HR]), we now switch our questioning to "Why?" At this point we seek to understand the rationale for a specific decision and asking "Why?" is more appropriate.

In this single string of logic, based on the evidence collected, we see 1) a conflict in roles and responsibilities between the contractor and the hospital and 2) violation of existing state codes.

The conflict in the roles and responsibilities is illuminated in the deposition transcripts, which show that the MRI technologists were unclear on both the immediate responsibility for checking the MRI's bulk oxygen cylinder and the larger issues of whether maintenance and upkeep of the MRI oxygen supply was the responsibility of the hospital or the MRI center. While

safety is not inherently compromised when an imaging facility is operated by a third-party contractor, the structural separation between hospital and MRI operations required a level of communication and coordination that was clearly absent in this situation.

Further evidence of this communication gulf was demonstrated when two prior MRI projectile accidents (neither resulted in injury) were discovered to have happened at the same facility in the months and years prior to the Colombini accident. The concealment of these accidents from the State of New York violated the Department of Health statutes, and the failure to communicate prior accidents within the institution (including a prior accident that involved ferromagnetic oxygen tanks, and the remediation step, which included using only non-ferromagnetic oxygen tanks within the MRI suite) contributed to the Colombini accident.

From these causes, a provider could identify a specific set of operational protections. For the failure of the piped-in oxygen system, these operational protections might include:

- MRI staff training on the operation of the medical gas system, including zone valves.
- Established responses for pressure/flow failures of medical gas service, including support from engineering.
- Exercised code procedures, which might include the use of MR-conditional portable medical gas cylinders and/or MRI scanner room evacuation.
