Case History #1: ISPAT Inland, Inc.

East Chicago, IN

UNDESIRABLE EVENT: Catastrophic Failure of #4 BOF (Basic Oxygen Furnace)
Lance Carriage Assembly in the Steel Making Area.

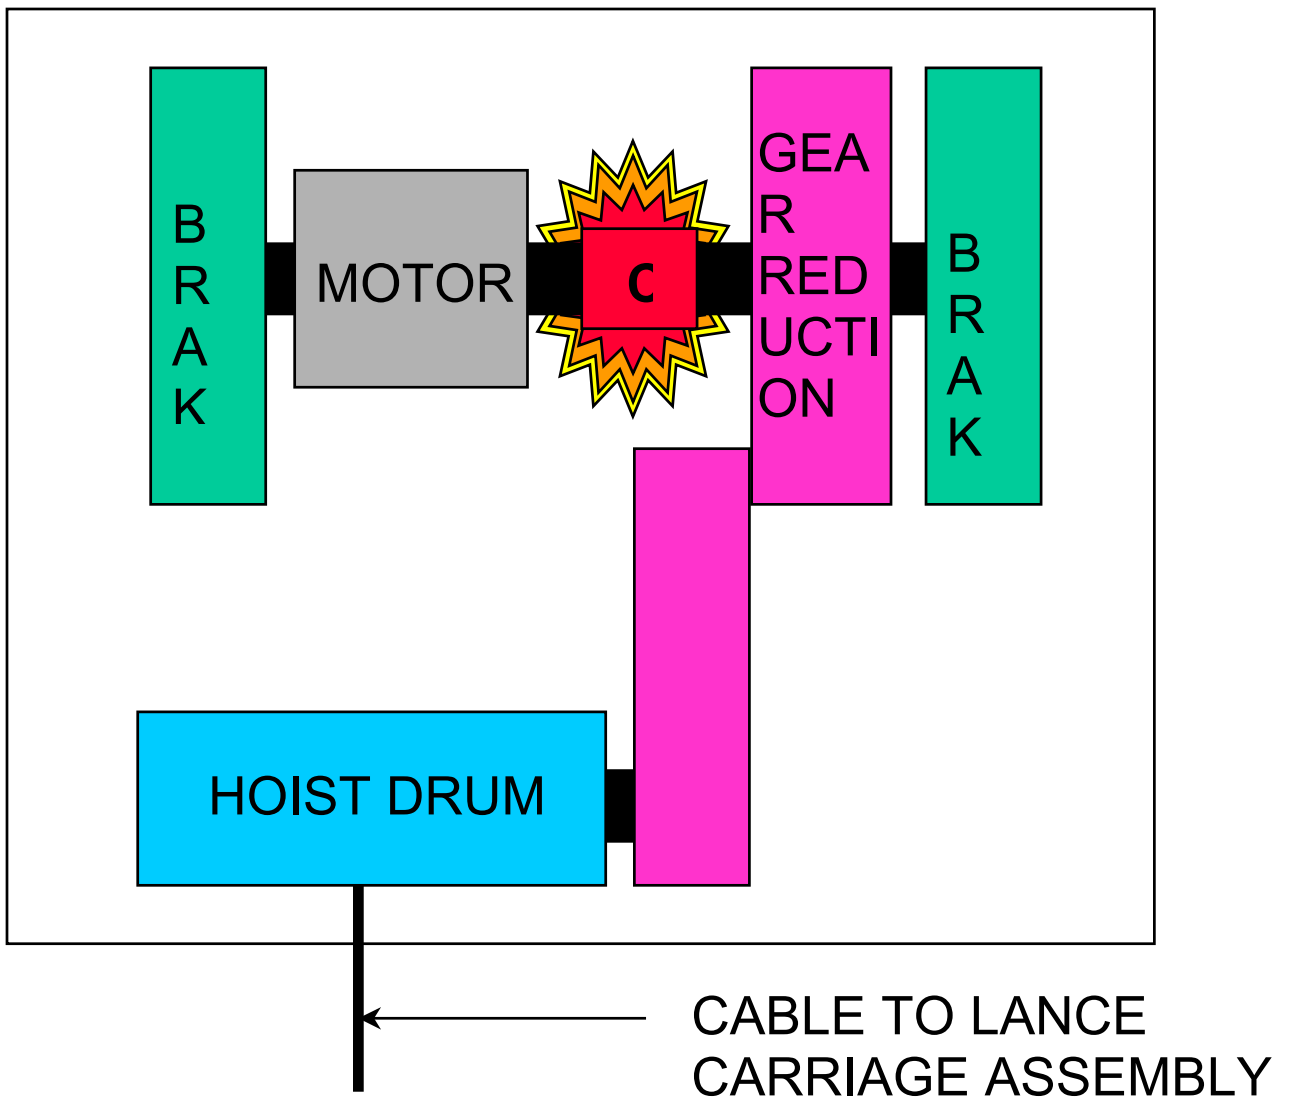
Figure 11.2: Hoist Drive Platform (Top View)

- Excessive Vibration
- Insufficient Motor Movement Prevents Proper Alignment
- Improper Gear Mesh
- Wrong Hug Nut Installed on Brake Pull Rod
- Debris Under Sheave Plate Could Have Prevented Movement
- Dirt/Graphite Not Cleaned Out
- Current Design Allows Dirt to Accumulate

- Precision Align All Components to Gear Reduction
- Re-Mesh All Gears
- Conduct Formal Training in Proper Alignment Practices
- Institute “Sign-Off” of Alignment on Drives
