Root Cause Analysis: Improving Performance for Bottom-Line Results

Case History #6

Weyerhaeuser Company
Valliant, OK

Catastrophic Failure of the Thermo Compressor Cone
for the # 3 Paper Machine

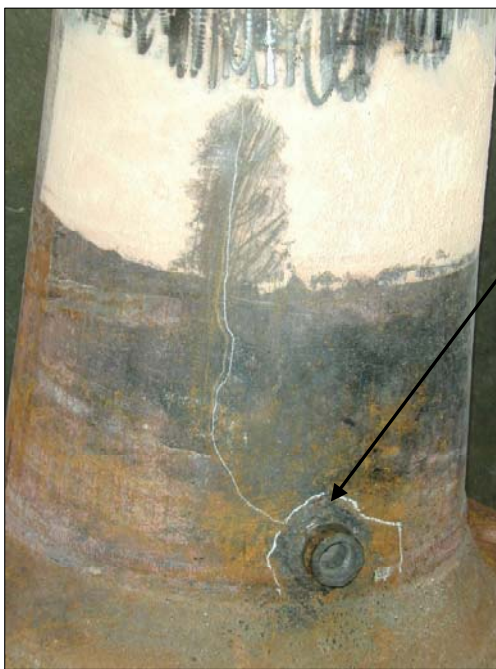
Figure 12.12: Crack Origin

UNDESIRABLE EVENT SUMMARY: New equipment for Paper Machine Number 3 was started up on March 1, 2000. After about two months service a crack developed around the gauge port of the Thermo Compressor propagating longitudinally from the toe of the fillet weld, around the gauge port, into the base material of the Thermo Compressor (Figure 12.12).

Crack Origin

Note that the crack branches turn in the lengthwise direction

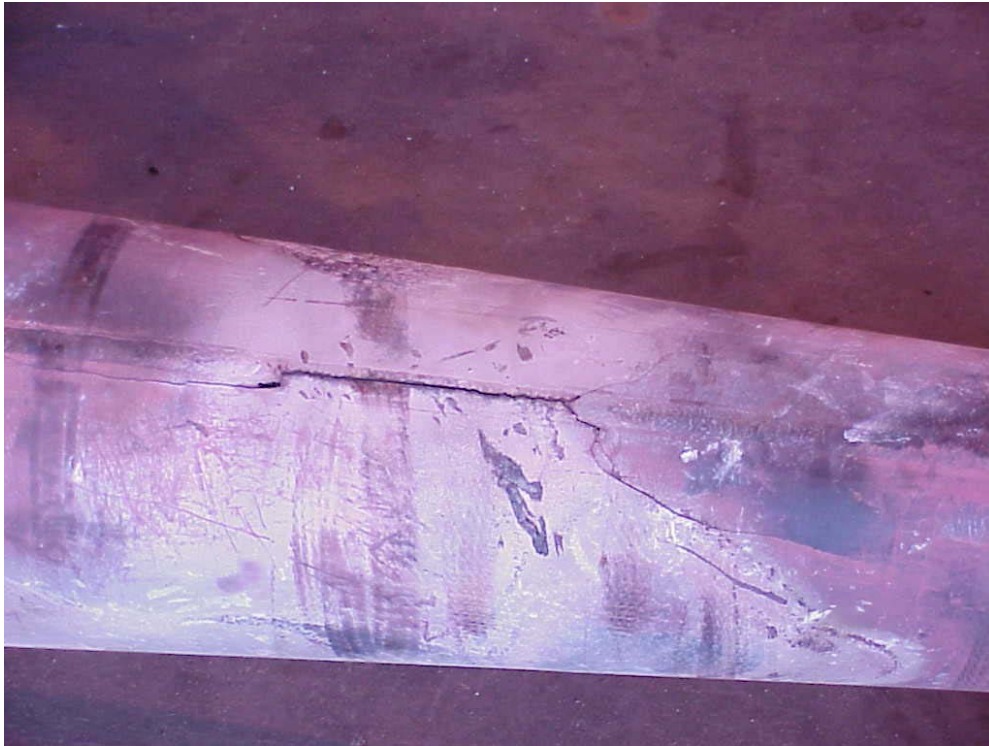
Figure 12.13: Crack Along Longitudinal Seam of Thermo Compressor Cone

The Thermo Compressor was replaced with a like component. After two days service, a leak developed at the longitudinal weld seam similar to the initial failure of the original Thermo Compressor (Figure 12.13).

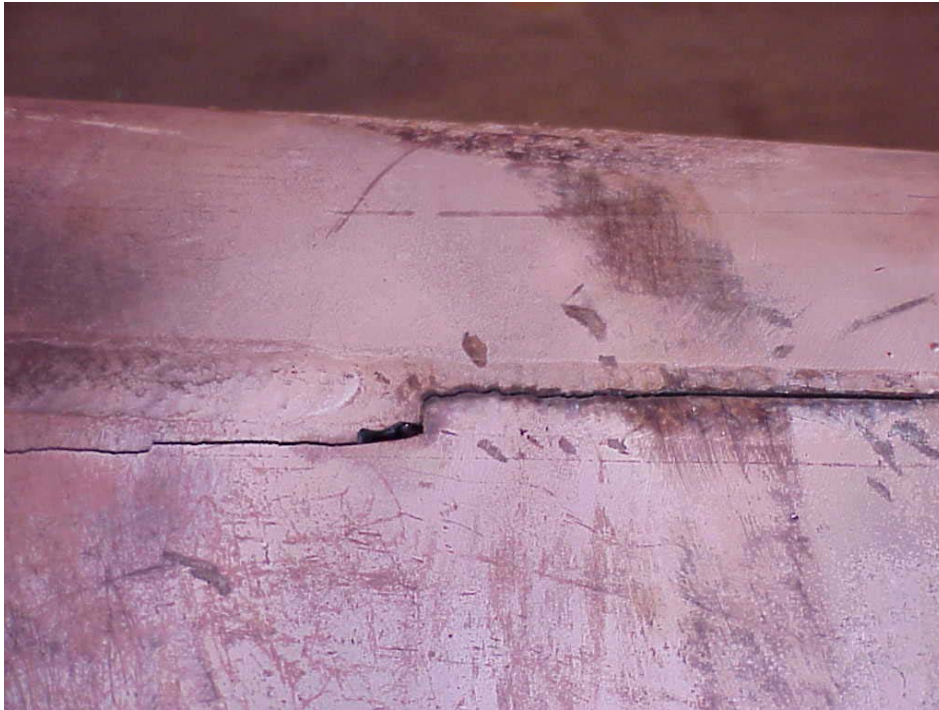
Figure 12.14: Weld Defects in Thermo Compressor

Thermo Compressor piping was visually inspected and subsequently analyzed because of the repeated failures of the cone attachments and the component body. In doing so, a conventional piping analysis of the design considering gravity, pressure and thermal growth forces showed that they were well within the appropriate standards during normal operation, both with and without the Thermo Compressor in service. Flaws in the pipe elbow of the Thermo Compressor were shown to progress into the piping wall and were, therefore, quite serious. In addition, visual inspection of the weld area revealed defects that contributed to the failure, including cracking and undercut (Figure 12.14).

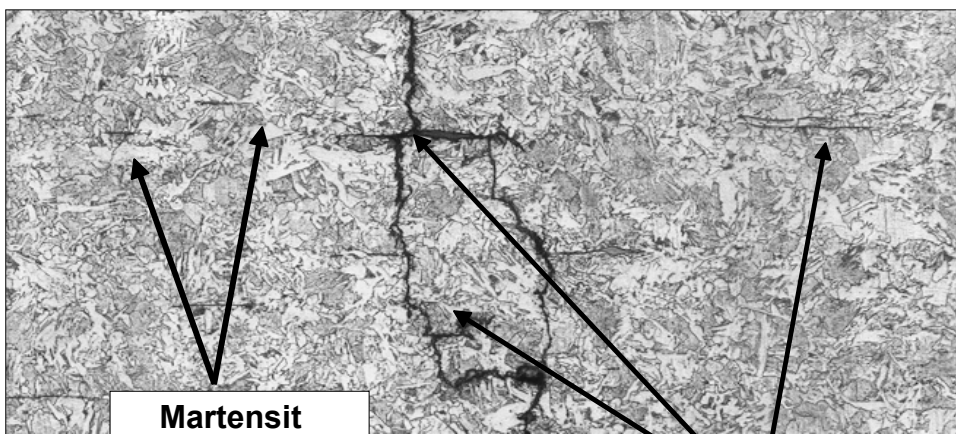
Figure 12.15: Microstructure Defects

Micro and Macro metallurgical examination of the weld area and heat affected zone uncovered additional weld application and heat-treating defects that accounted for the stepping appearance of the cracks. These examinations showed that the cracking followed a pattern that stepped from filler and base metal inclusions (Figure 12.15) on a background tempered martensite base metal microstructure. In essence, the crack approximated a pattern that represented flaws in the cone's metallurgical microstructure, or the path of least resistance throughout the filler and base metals of the Thermo Compressor's cone shaped body.

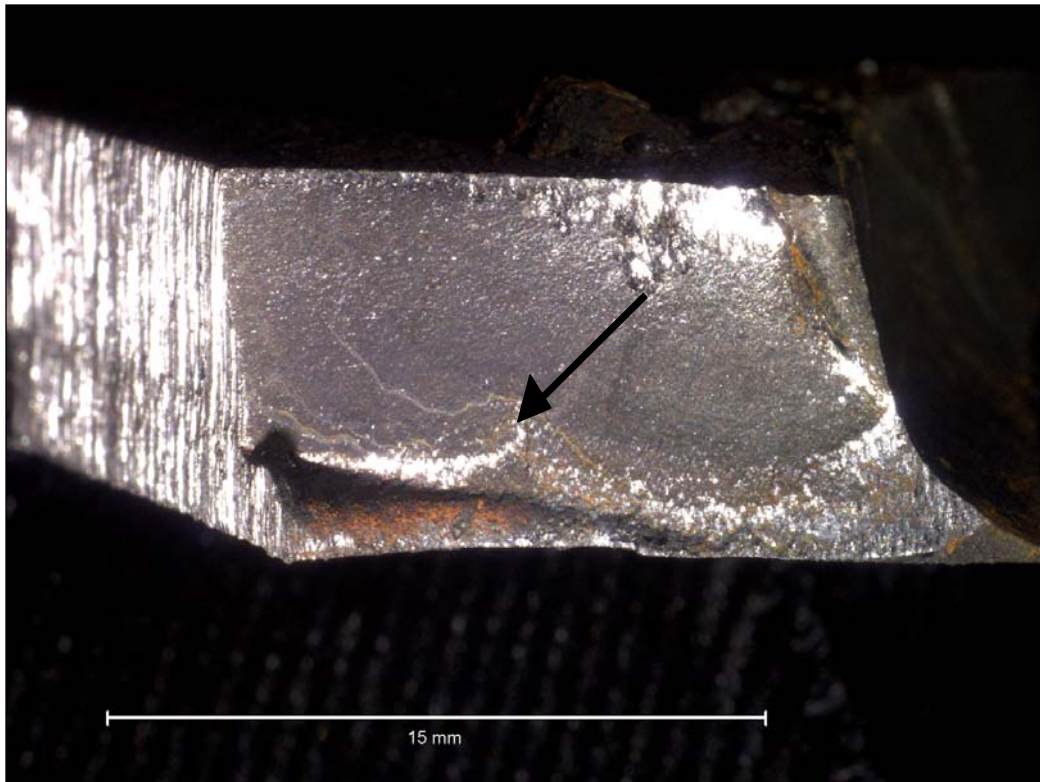
Figure 12.16: Fatigue Indications

Visual examination of the weld's crack cross sectional area showed evidence of fatigue contributing to the failure of the Thermo Compressor Cone. As illustrated in (Figure 12.16), the arrow shows the direction of the crack in the base metal. In addition, upon further close examination you can see circular beach marks that fan out from the outside diameter of the cone. This combined with the ratchet marks and a generally flat surface, are clear indications of a fatigue related failure demanding further examination of the process.

To confirm fatigue as a contributor to the failure being analyzed, pipe wall flexure natural frequencies in the piping that constitute the Thermo Compressor were identified with numerical methods and confirmed through testing by plant personnel in the field under operating conditions. Here it was determined that the natural frequency mode shapes were consistent with the location and orientation of the cracks. Furthermore, all failure modes – attached cracking, loosening nuts, and cracked cone – are consistent with the vibration induced from Thermo Compressor operation. The analytical conclusion of

the source of the fluctuating stress that was producing the fatigue failures was determined to be pipe wall resonance, and that any coincidental acoustical resonance would synergistically magnify this vibratory stress.

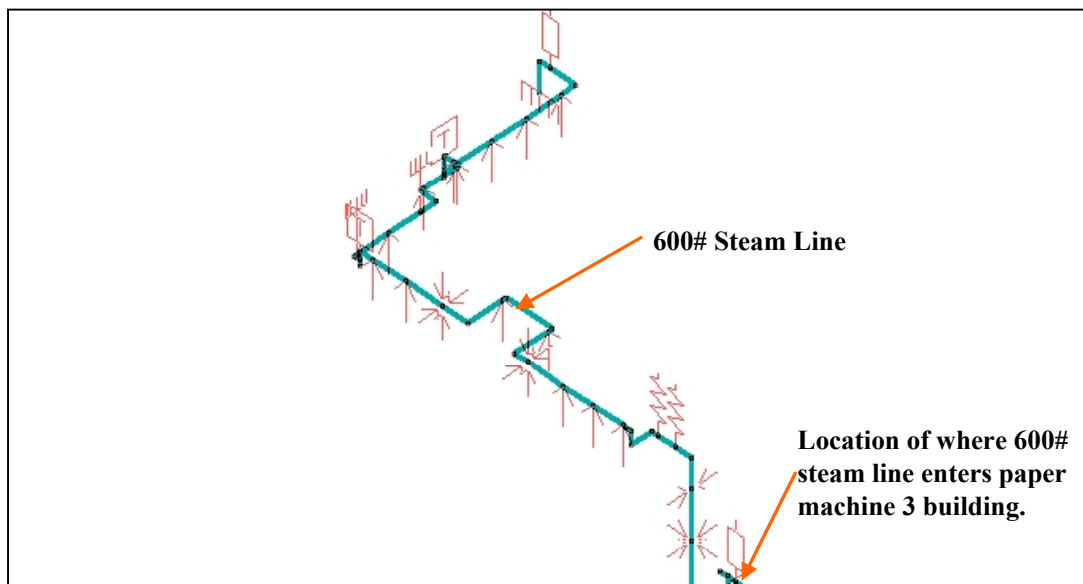
Figure 12.17: Piping System with 65 psig Steam Header Excluding Expansion Loop

The system analyzed for gravity, pressure and thermal stress is illustrated in (Figure 12.17). The existing 65 psig steam header was limited in the model because it appeared to be unnecessary.

Piping stress in and around the Thermo Compressor was determined to be low and there was seemingly no correlation between the failures and piping stress from gravity, pressure and thermal loadings.

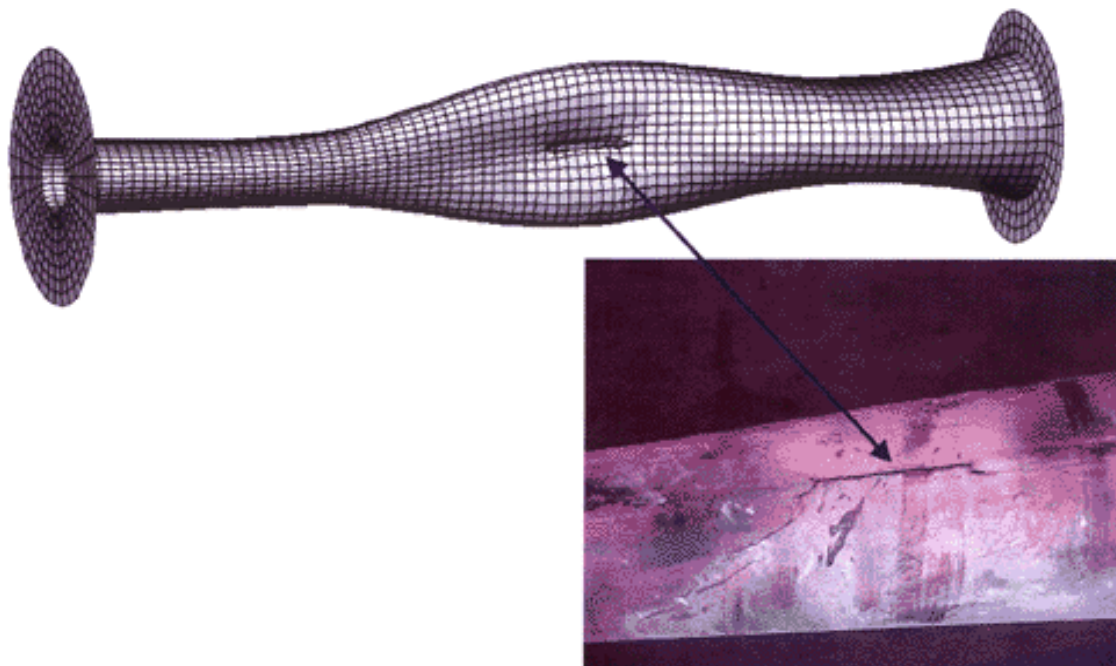
Figure 12.18: Dynamic Finite Element Model of the Thermo Compressor Cone Showing a Fundamental 540 Hz Natural Frequency Pipe Wall Flexure Mode

Vibration of the piping from which the Thermo Compressor cone is constructed was analyzed by constructing a finite element computer model. Several natural frequencies were identified by dynamic analysis. The natural frequency mode shape that occurs at 540 Hz (seen in Figure 12.18) shows a pipe wall flexure that will produce the highest stress at precisely the location of an experienced crack. In addition, the stress will also fluctuate, which is a necessary prerequisite for fatigue cracking.

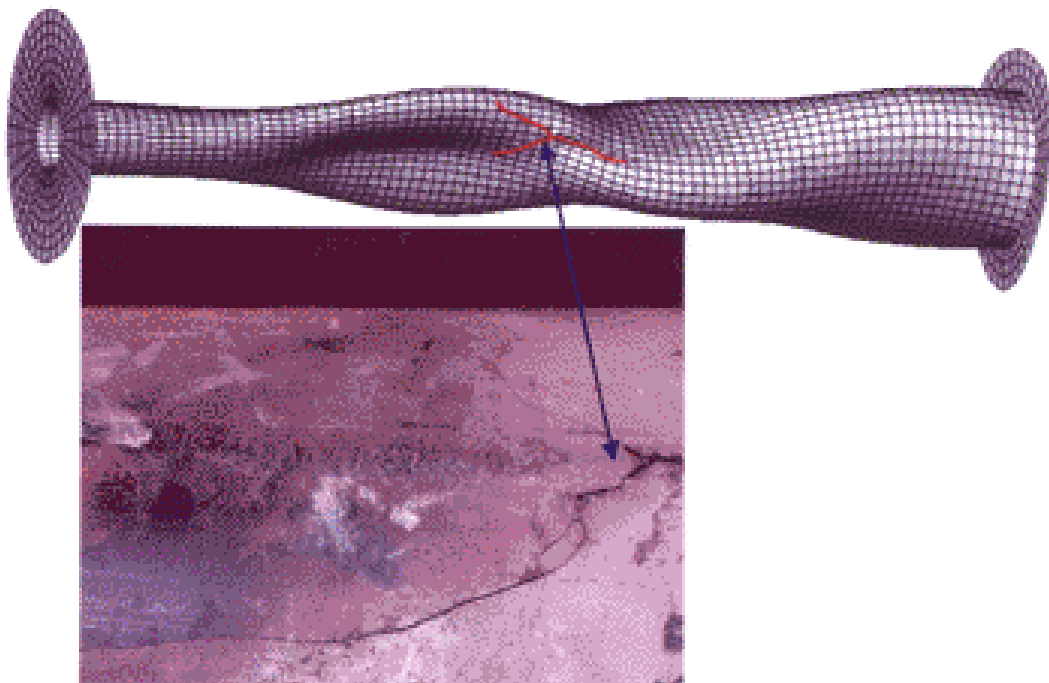
Figure 12.19: Natural Frequency Mode at 777 Hz

The mode shape of (Figure 12.18) does not explain the initial crack branching into two cracks at the left end. The mode shape of (Figure 12.19) shows the initial crack running into high fluctuating stress fields that are at nominally 45 degrees on either side. The concave and convex areas alternate and provide the fluctuating high stress fields necessary for the fatigue crack to advance in their directions.

Field measurement of the thicker cone showed a strong, undamped resonance at 780 Hz (46,000 cpm). This coincides with the 777 Hz natural frequency of the pipe wall and explains the axial crack branching to higher stress fields.

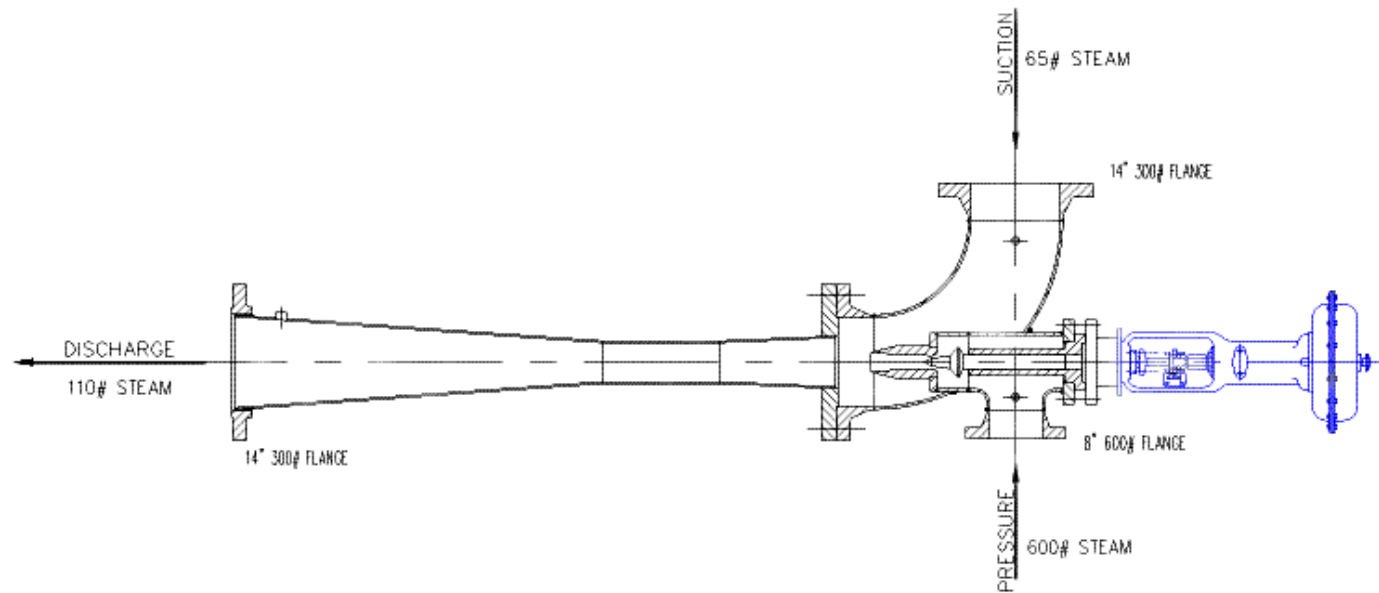
Insert Figure 12.20: Thermo Compressor

The piping elbow that forms the Thermo Compressor had weld flaws that extended into the wall of the elbow (Figure 12.20).
