Wheel Bearing Problem

Verification Data

Rear Passenger Wheel Bearing Premature Failure

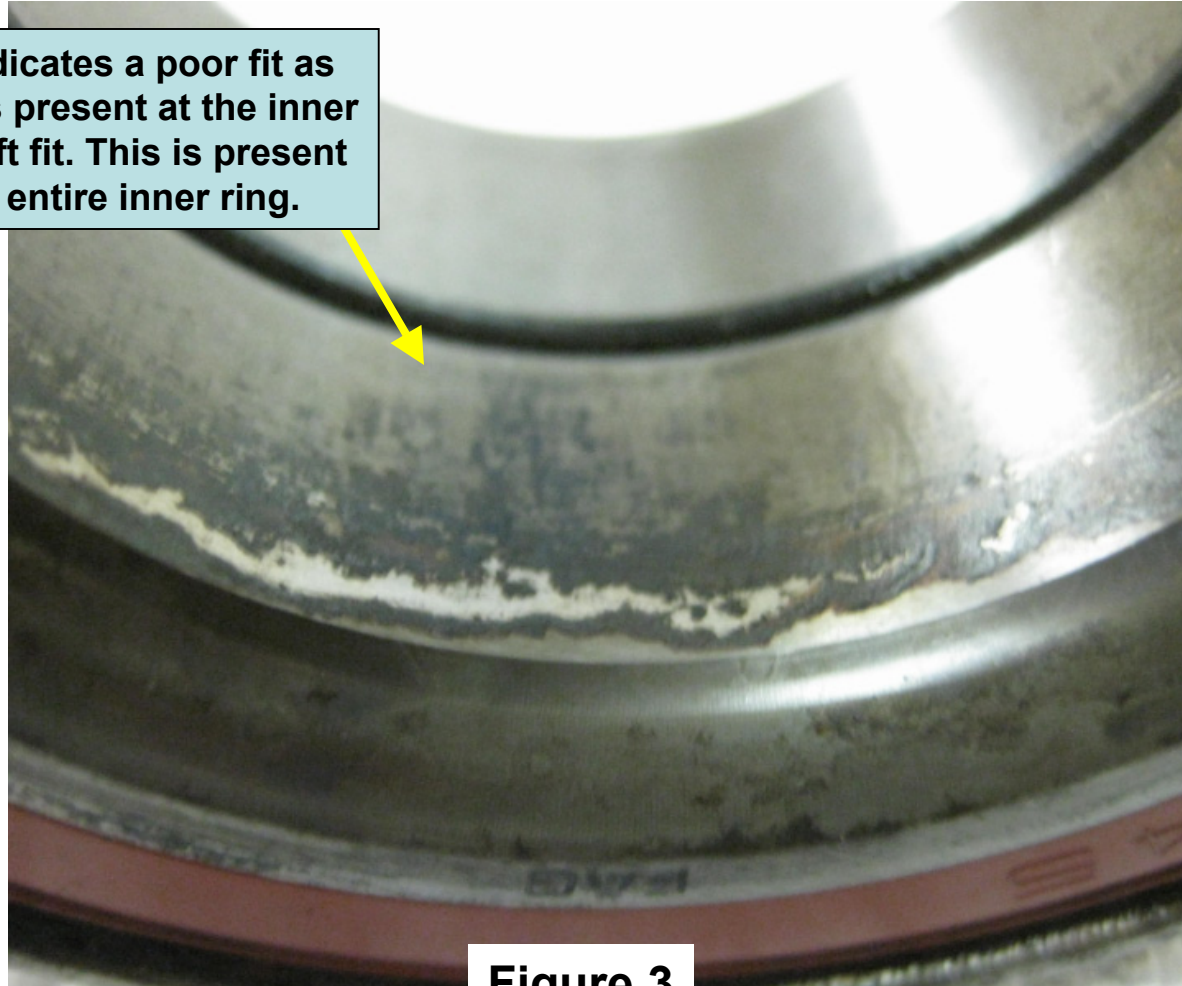
Figure 3

The inner ring on the side opposite of the identification showed little fretting.

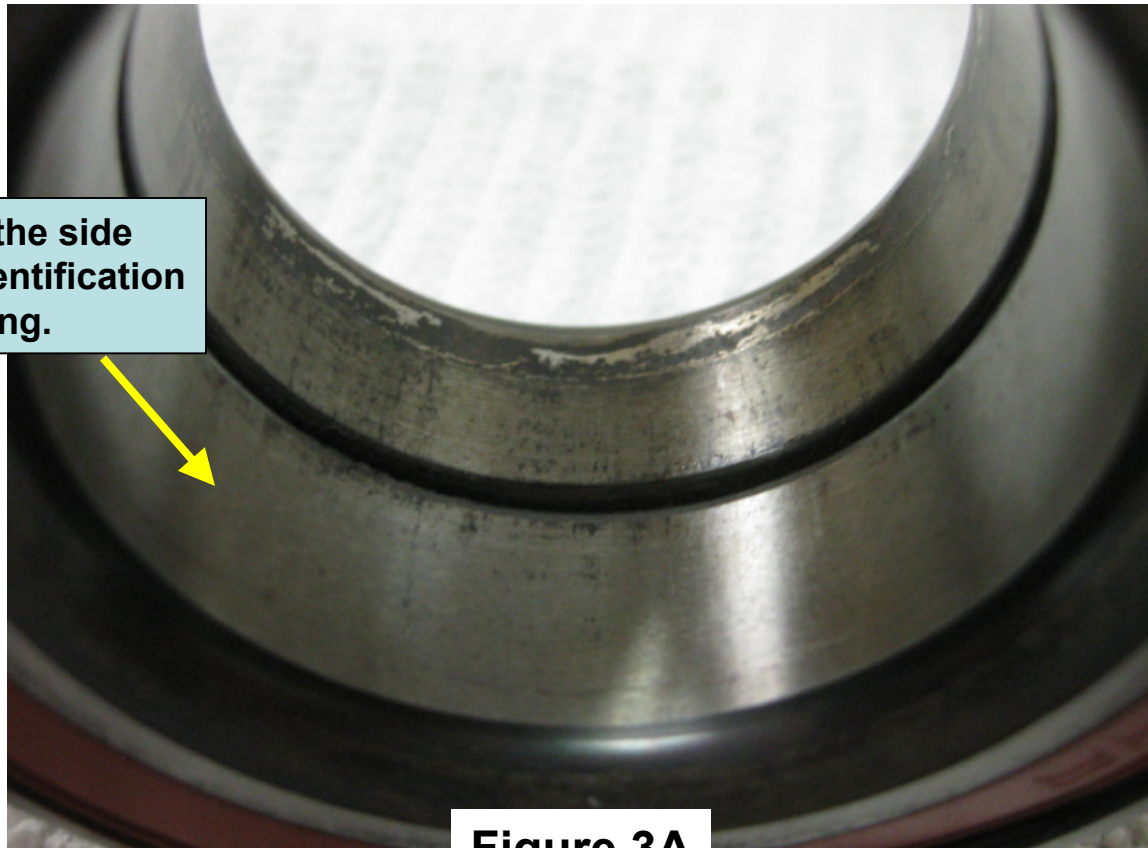
Figure 3A

The fatigue damage
is consistent with the
inner ring fretting

The fatigue damage

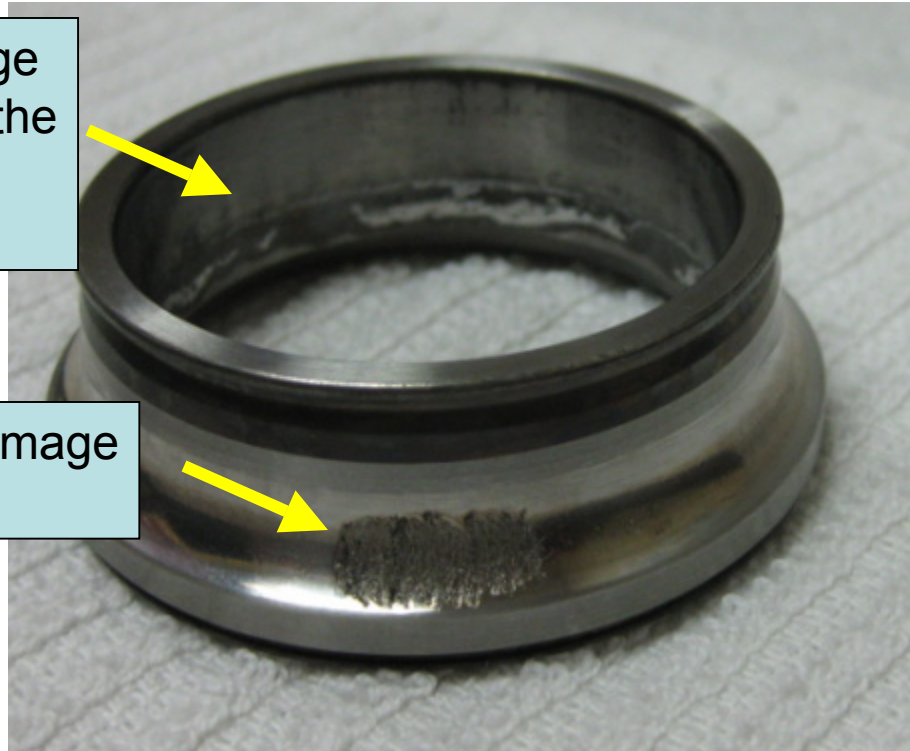
Figure 3B

The other inner ring showed little temperature and the early stages of fatigue spalling

No significant signs of fretting
On the other inner ring.

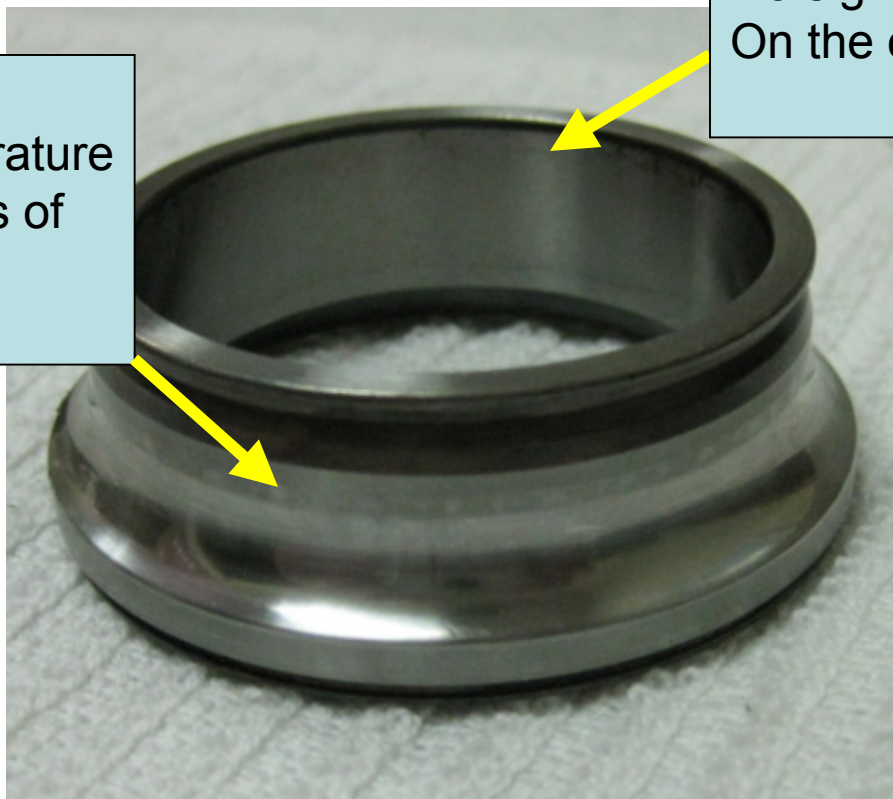
Figure 3C

The outer ring proof that the bearing was spinning in the housing . The damage is consistent with rotation

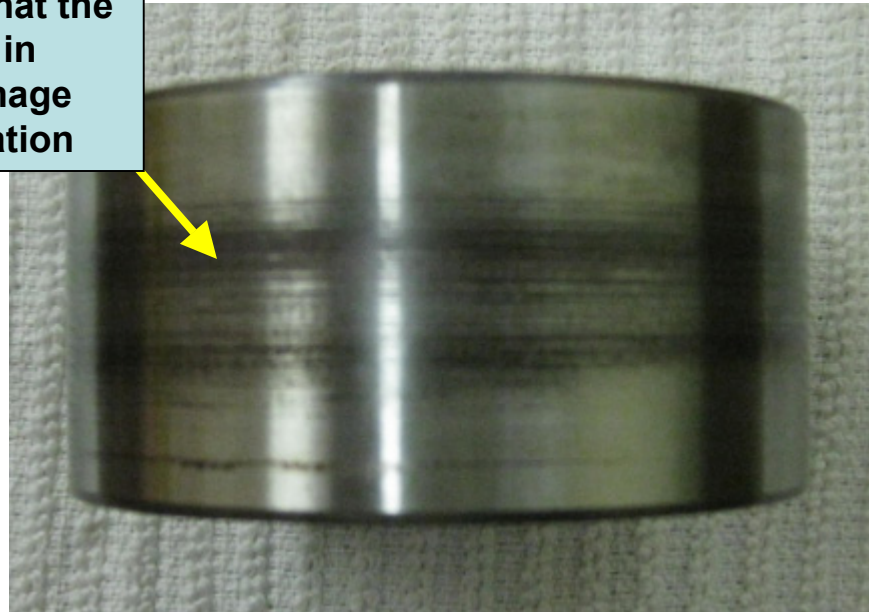
Figure 4

The outer ring spinning
damage close-up of damage

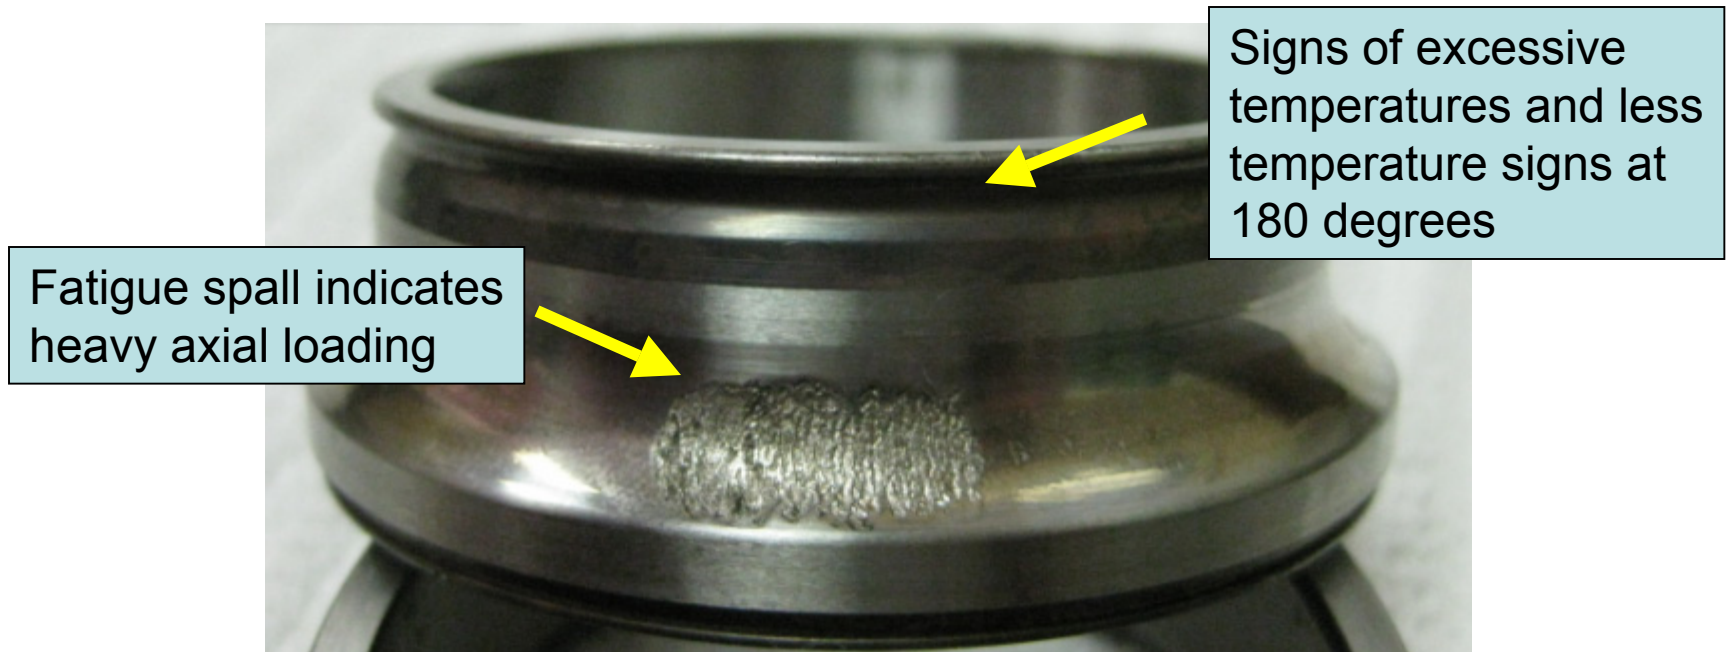
Figure 5

The discoloration was in the brown yellow range or about 500F. Enough to damage the lubrication.

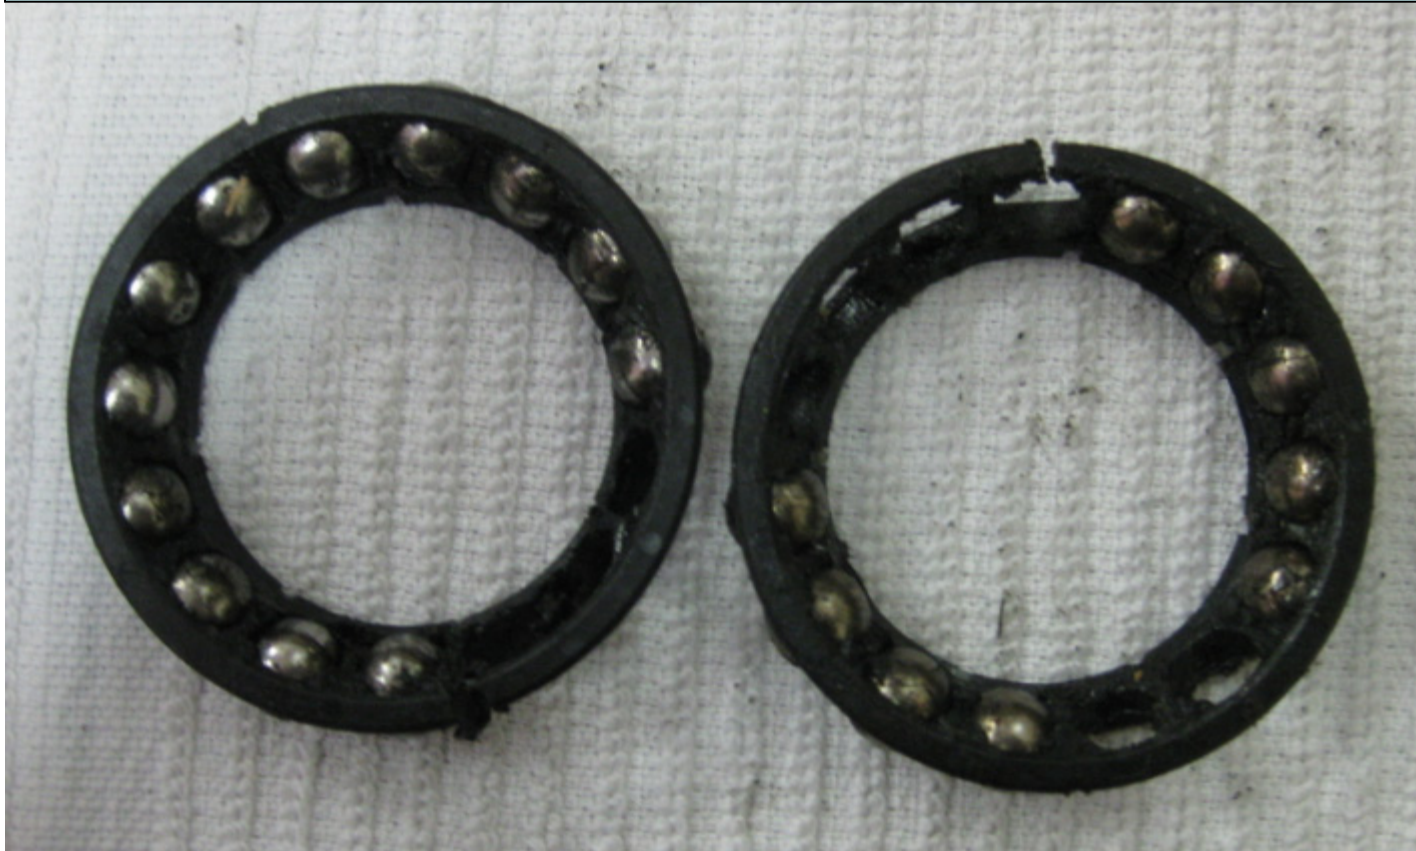
Figure 6

The roller cage side 2 is in tact with no apparent damage except where cuts to open were made.

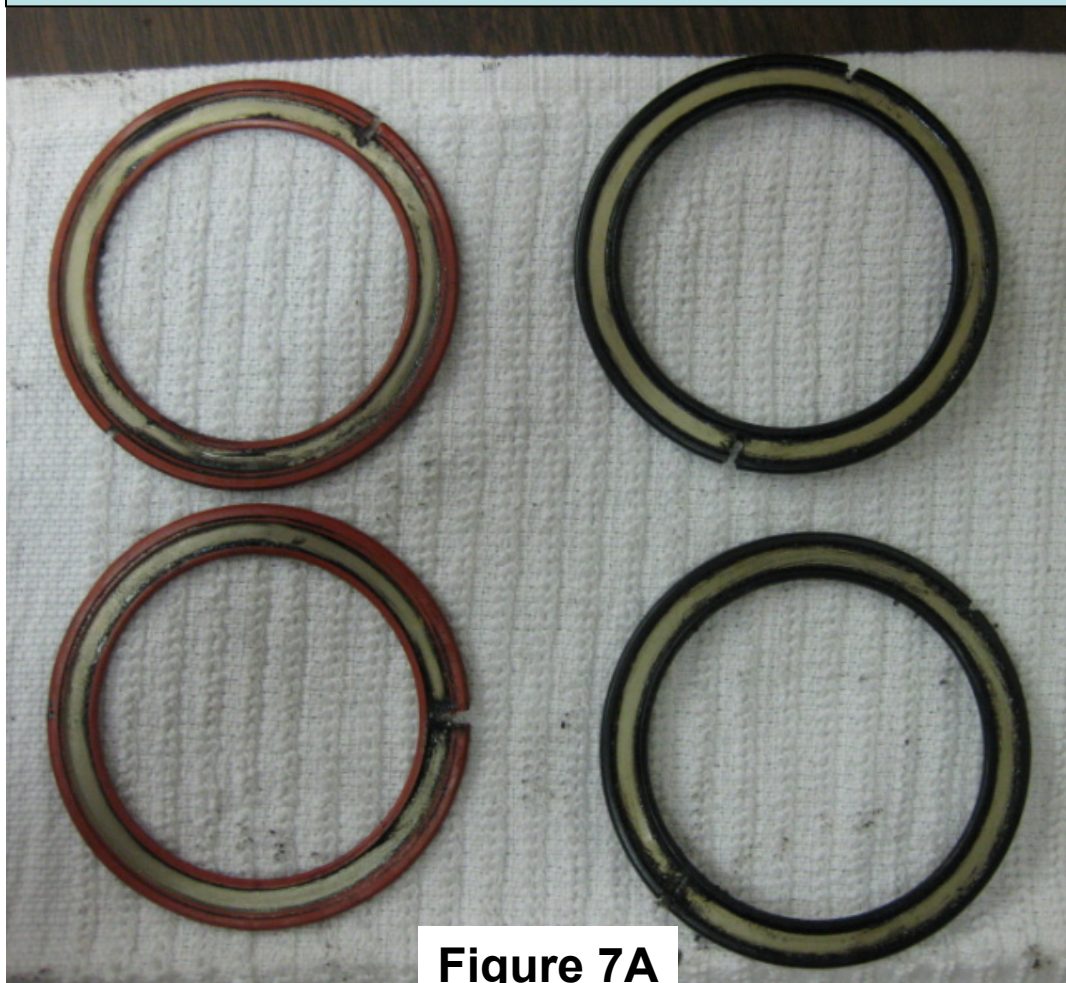
Figure 7A

Bearing Seals - side 2 No apparent problems except where the cuts to open were made
