# Case History #1: ISPAT Inland, Inc.

East Chicago, IN

**UNDESIRABLE EVENT:** Catastrophic Failure of #4 BOF (Basic Oxygen Furnace)  
Lance Carriage Assembly in the Steel Making Area.

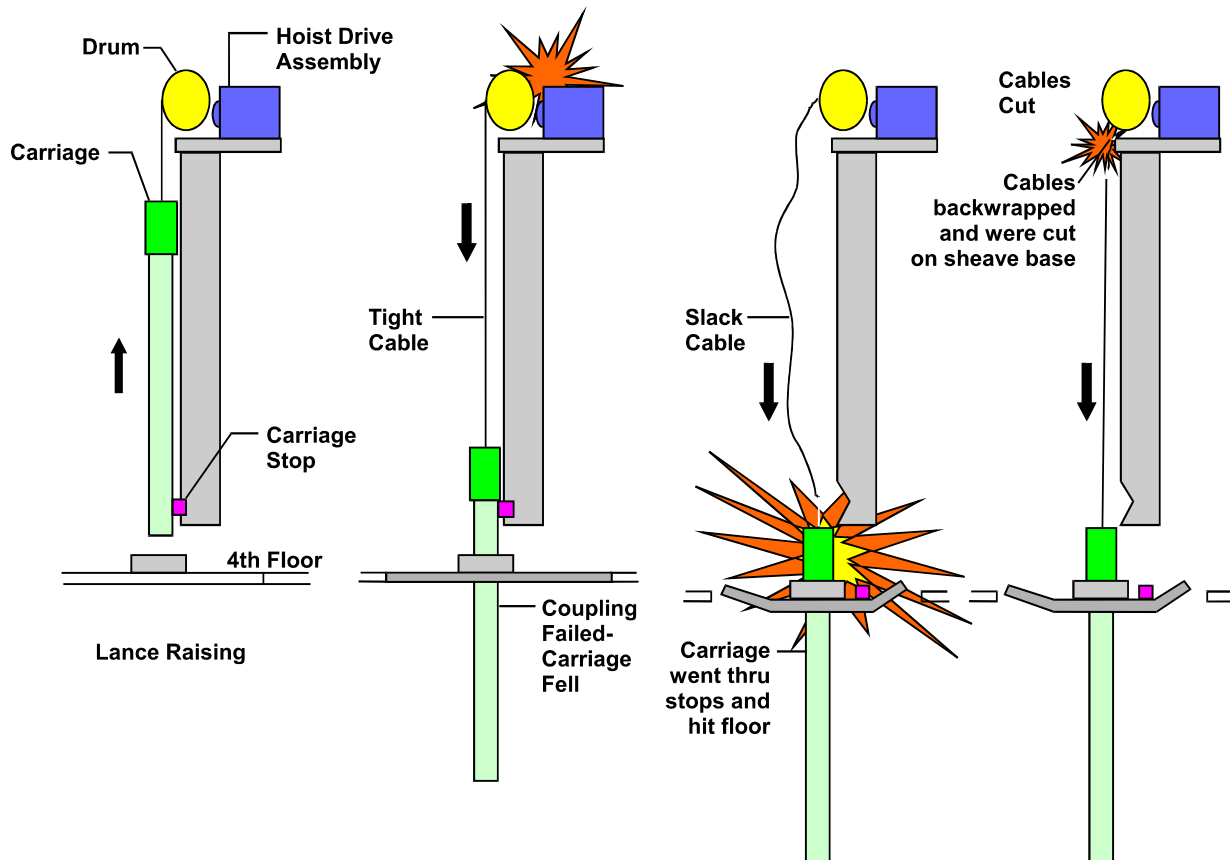
Figure 11.1: Lance Carriage Free Fall

**UNDESIRABLE EVENT SUMMARY:** During a routine slag wash, the operator in the pulpit (control room) was raising the 11-ton lance carriage. While raising the lance to its idle position approximately 80' above the fourth floor, a coupling on the drive platform failed, sending the lance carriage into a free fall. The carriage broke through the stop bolts and crashed into the 4<sup>th</sup> floor.

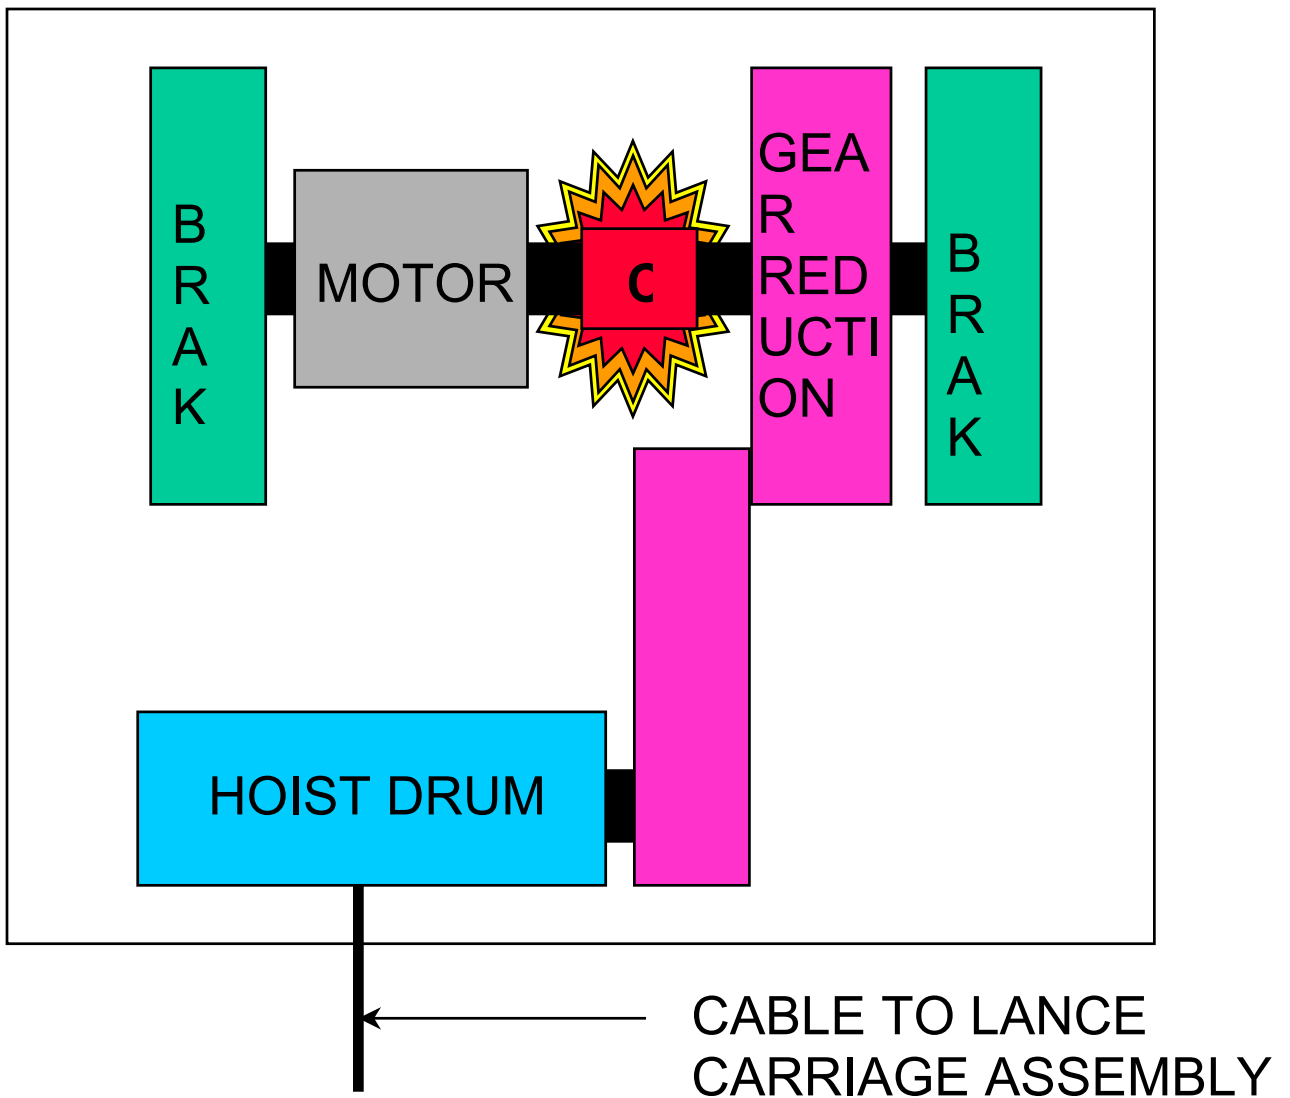
Figure 11.2: Hoist Drive Platform (Top View)

- Excessive Vibration
- Insufficient Motor Movement Prevents Proper Alignment
- Improper Gear Mesh
- Wrong Hug Nut Installed on Brake Pull Rod
- Debris Under Sheave Plate Could Have Prevented Movement
- Dirt/Graphite Not Cleaned Out
- Current Design Allows Dirt to Accumulate

- Precision Align All Components to Gear Reduction
- Re-Mesh All Gears
- Conduct Formal Training in Proper Alignment Practices
- Institute “Sign-Off” of Alignment on Drives
