Root Cause Analysis: Improving Performance for Bottom-Line Results

Case History #6

Weyerhaeuser Company
Valliant, OK

Catastrophic Failure of the Thermo Compressor Cone
for the # 3 Paper Machine

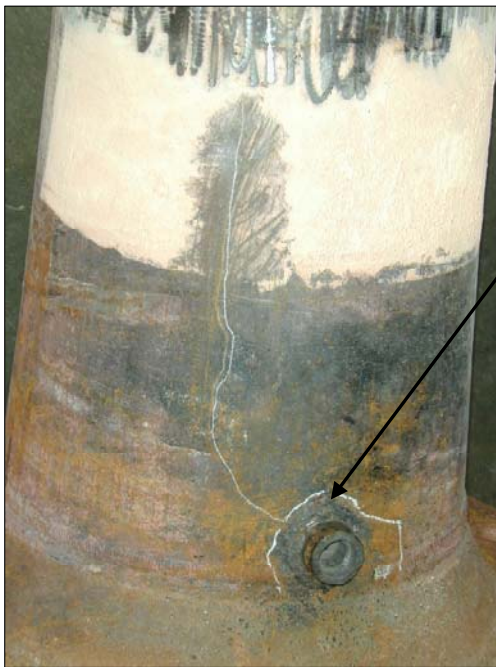
Figure 12.12: Crack Origin

UNDESIRABLE EVENT SUMMARY: New equipment for Paper Machine Number 3 was started up on March 1, 2000. After about two months service a crack developed around the gauge port of the Thermo Compressor propagating longitudinally from the toe of the fillet weld, around the gauge port, into the base material of the Thermo Compressor (Figure 12.12).

Crack Origin

Note that the crack branches turn in the lengthwise direction

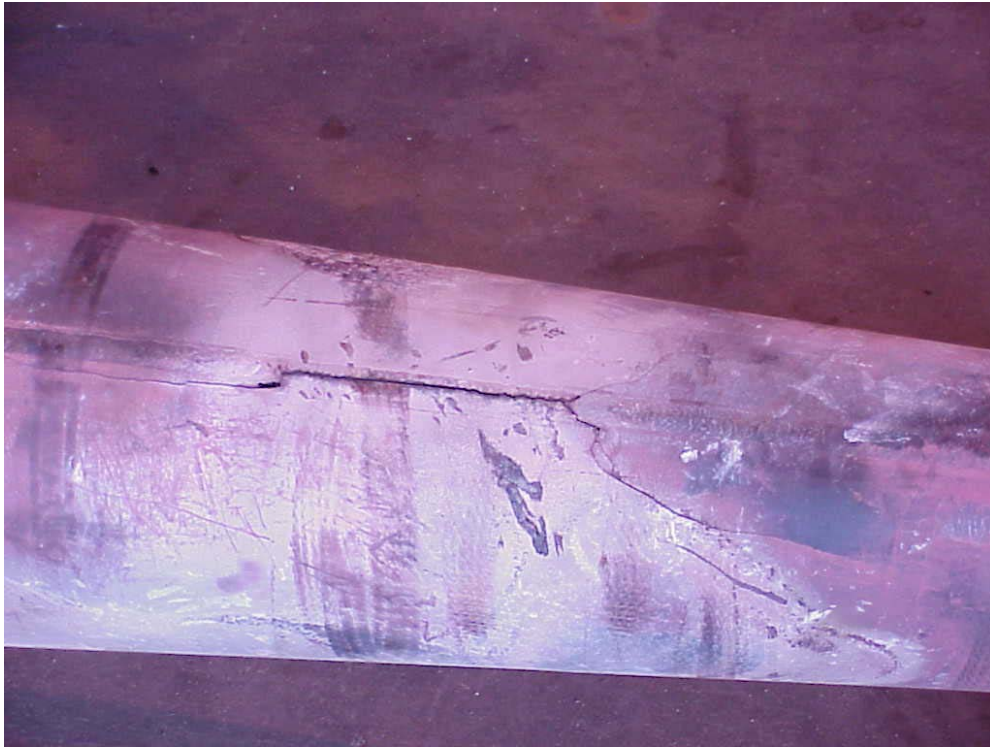
Figure 12.13: Crack Along Longitudinal Seam of Thermo Compressor Cone

The Thermo Compressor was replaced with a like component. After two days service, a leak developed at the longitudinal weld seam similar to the initial failure of the original Thermo Compressor (Figure 12.13).

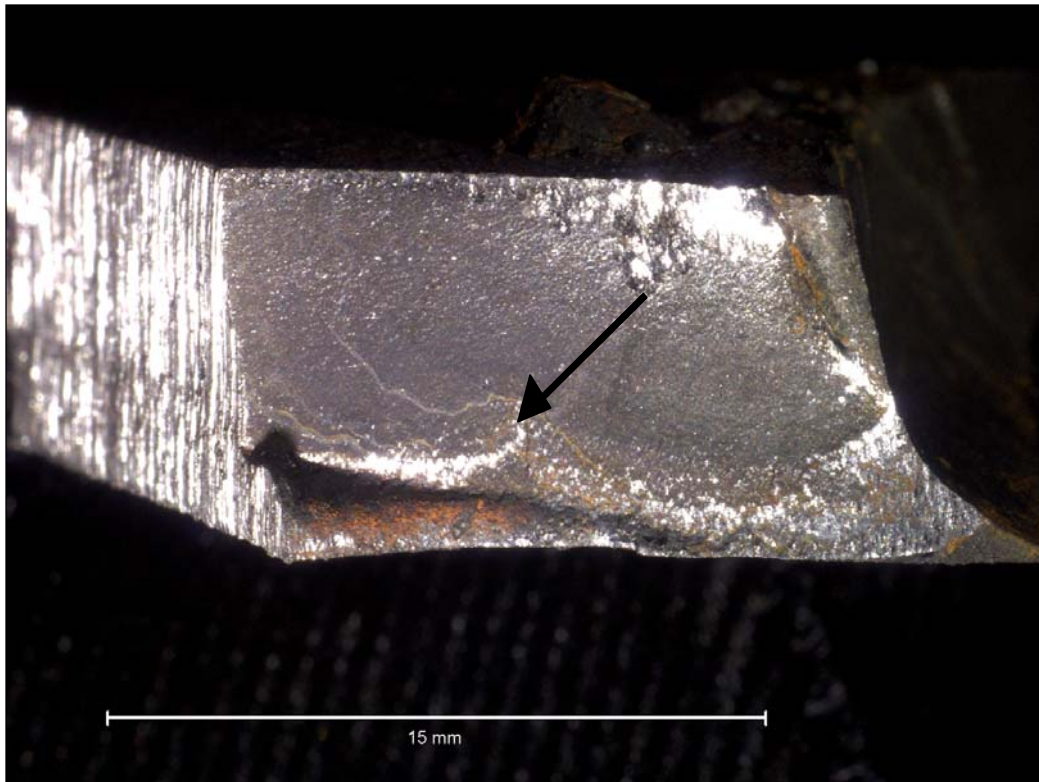
Figure 12.16: Fatigue Indications

Visual examination of the weld's crack cross sectional area showed evidence of fatigue contributing to the failure of the Thermo Compressor Cone. As illustrated in (Figure 12.16), the arrow shows the direction of the crack in the base metal. In addition, upon further close examination you can see circular beach marks that fan out from the outside diameter of the cone. This combined with the ratchet marks and a generally flat surface, are clear indications of a fatigue related failure demanding further examination of the process.

To confirm fatigue as a contributor to the failure being analyzed, pipe wall flexure natural frequencies in the piping that constitute the Thermo Compressor were identified with numerical methods and confirmed through testing by plant personnel in the field under operating conditions. Here it was determined that the natural frequency mode shapes were consistent with the location and orientation of the cracks. Furthermore, all failure modes – attached cracking, loosening nuts, and cracked cone – are consistent with the vibration induced from Thermo Compressor operation. The analytical conclusion of

the source of the fluctuating stress that was producing the fatigue failures was determined to be pipe wall resonance, and that any coincidental acoustical resonance would synergistically magnify this vibratory stress.

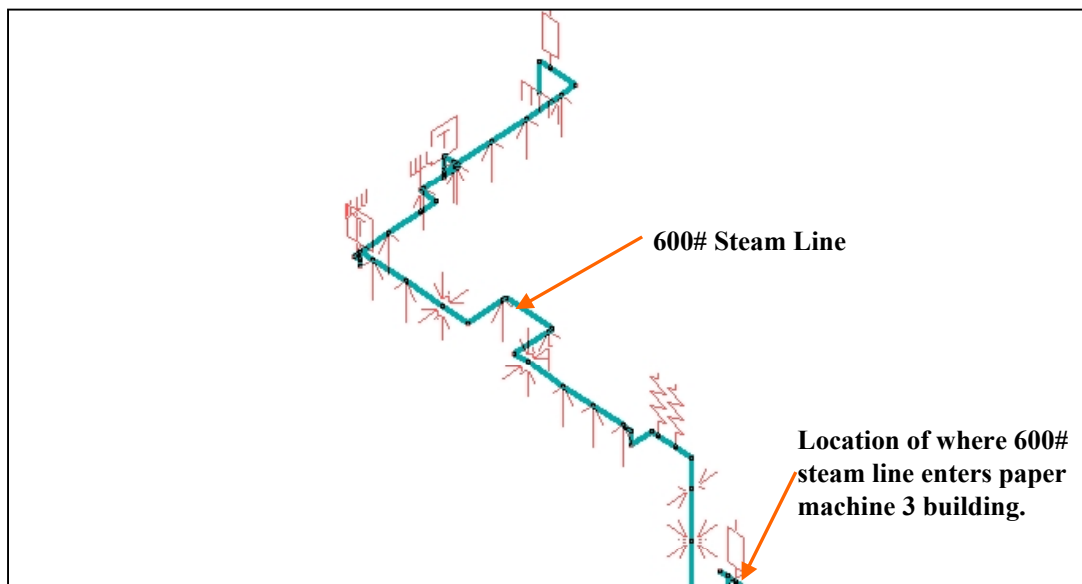
Figure 12.17: Piping System with 65 psig Steam Header Excluding Expansion Loop

The system analyzed for gravity, pressure and thermal stress is illustrated in (Figure 12.17). The existing 65 psig steam header was limited in the model because it appeared to be unnecessary.

Piping stress in and around the Thermo Compressor was determined to be low and there was seemingly no correlation between the failures and piping stress from gravity, pressure and thermal loadings.

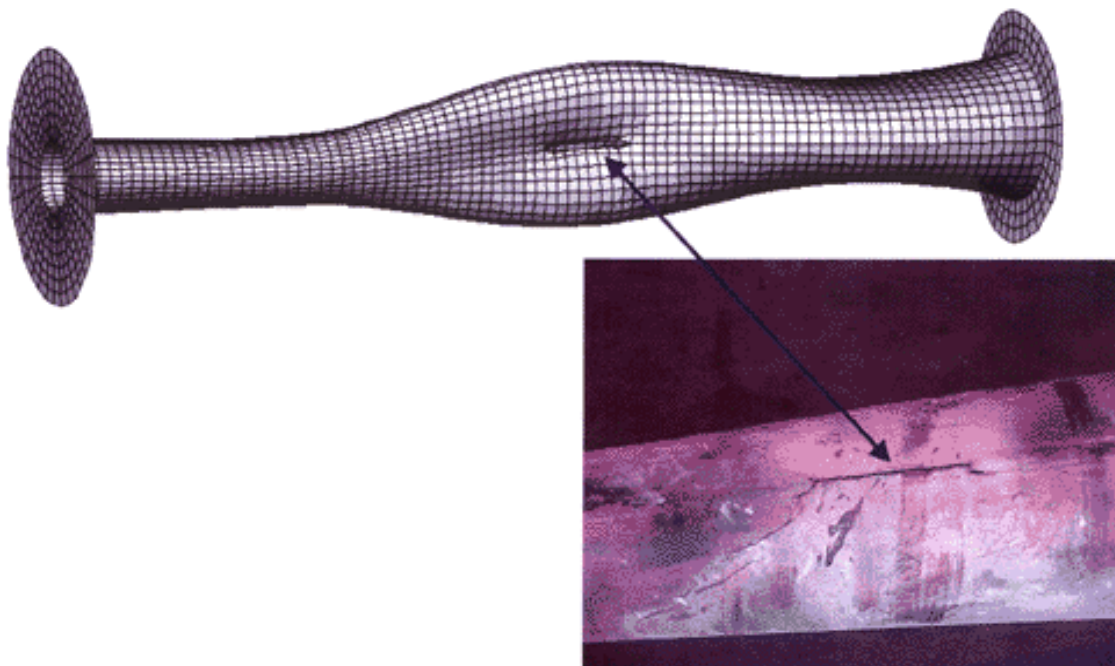
Figure 12.18: Dynamic Finite Element Model of the Thermo Compressor Cone Showing a Fundamental 540 Hz Natural Frequency Pipe Wall Flexure Mode

Vibration of the piping from which the Thermo Compressor cone is constructed was analyzed by constructing a finite element computer model. Several natural frequencies were identified by dynamic analysis. The natural frequency mode shape that occurs at 540 Hz (seen in Figure 12.18) shows a pipe wall flexure that will produce the highest stress at precisely the location of an experienced crack. In addition, the stress will also fluctuate, which is a necessary prerequisite for fatigue cracking.
