## **ALABAMA POWER IMPACTS BOTTOM-LINE USING THE PROACT<sup>®</sup> ROOT CAUSE ANALYSIS SYSTEM**

By Ronny Johnston, Maintenance Planner, Alabama Power Co.

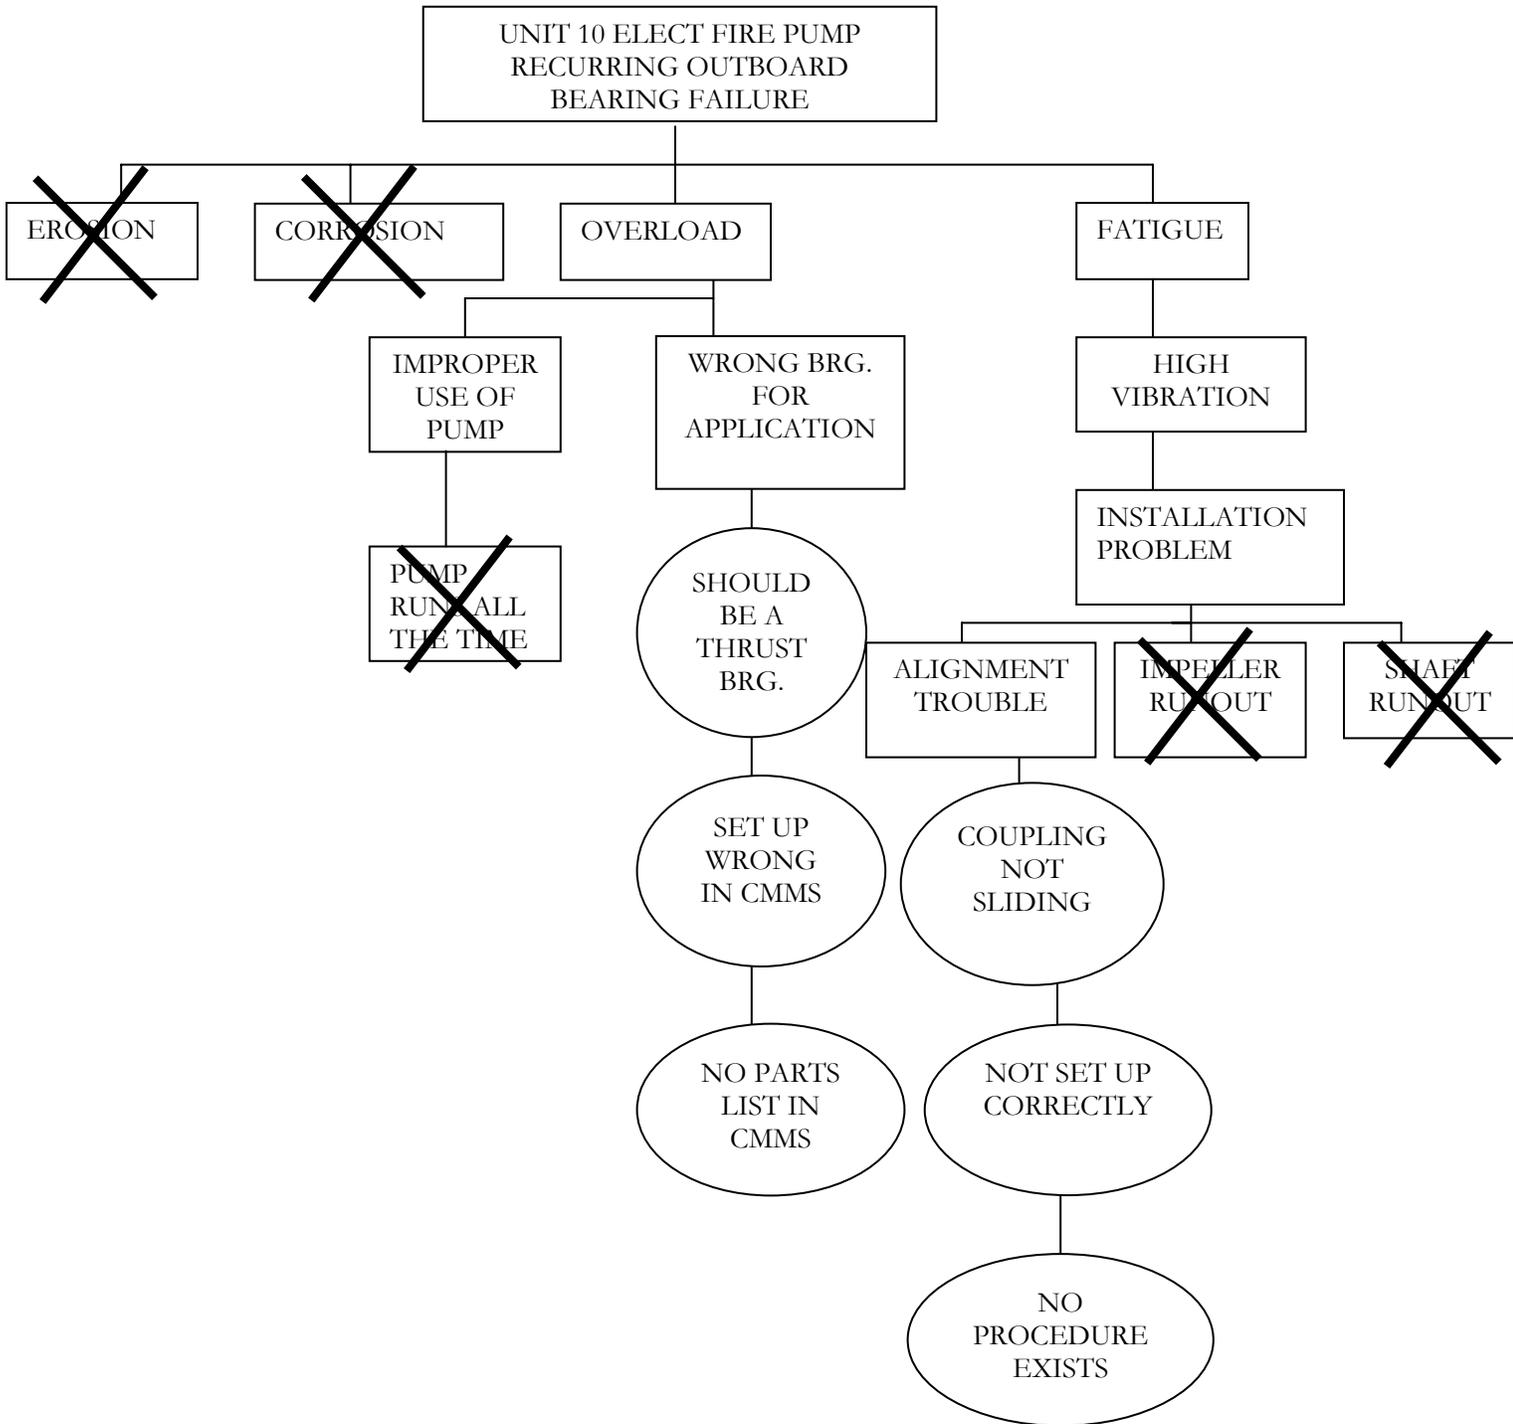
LOGIC TREE FOR UNIT 10 FIRE PUMP FAILURES

After a team review of how the PROACT<sup>®</sup> process worked, a logic tree was developed to graphically represent the cause and effect relationships that could have lead to the event occurring. All of the hypotheses that could be eliminated based on hard facts, were ruled out and some team assignments were made for those hypotheses that still required verification. During the team meetings it was brought out that the outboard bearing was the thrust bearing. IT was also explained to the other team members how they could identify a roller bearing that was a thrust bearing. Team members were assigned to retrieve the failed bearings and start the process of finding out why it failed. Team members were also assigned to locate an instruction manual and any other documentation possible.

It turned out that the old bearing was not a thrust bearing after all. The mechanics had been replacing the burned up bearings with the same type they had removed from the pump, which was the wrong bearing. Further investigation revealed that the CMMS (computerized maintenance management system) listed only one bearing for this fire pump and its description did not indicate it was the inboard bearing. The storeroom did have the correct bearing for the outboard but it was not listed for this pump.

1. Have the description for the inboard bearing changed in the CMMS to read inboard bearing
2. Have the out board bearing set up in CMMS with an improved description.
3. Purchase or develop an accurate instruction manual for the fire pump.
4. Add a parts list to CMMS for the fire pump.
5. Add a procedure to CMMS with an accurate and user-friendly checklist for the fire pump.
6. Have some training for Mechanics and E&I on proper alignment and procedures for checking magnetic center.
