Why Trending is Important to Predictive Activities

Mark A. Latino, President, Reliability Center, Inc.

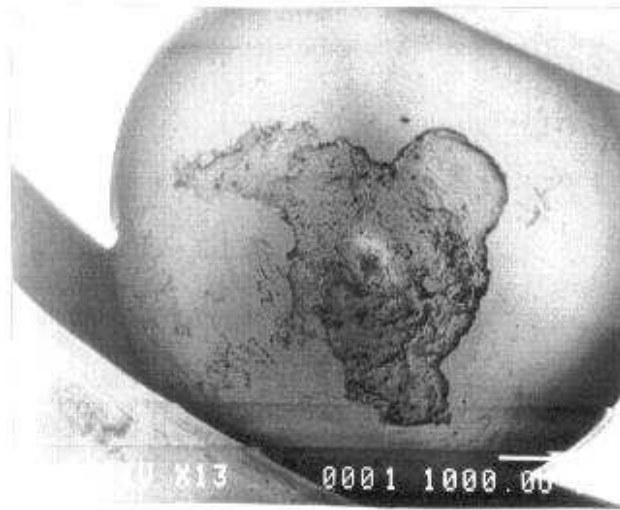
Figure 1

a small person to get far enough in to do the inspection. The results were conclusive the visual images showed the damage on the bearing rollers see *figure 1*.

Now there was complete confidence in proceeding forward with the repair. When the maintenance crew had completed the removal of the gearbox assembly a thorough visual inspection was conducted in order to determine the failure mechanism. The results of the inspection revealed that the cam that the gearbox drove had significant damage because the cam follower bearing had failed, the closest gear to the gearbox had tooth damage, and the 1208 bearing that had shown up on the vibration signature was a double roller bearing instead of a single roller bearing as the drawing had indicated. This explained why the frequency placement didn't line up. The primary failure was the cam follower bearing had failed the secondary failures were the 1208 bearing damage, Cam damage, and gear damage.
