## Analyzing fires using PROACT® Methodology and Software Case Study: Hauler Truck Fire

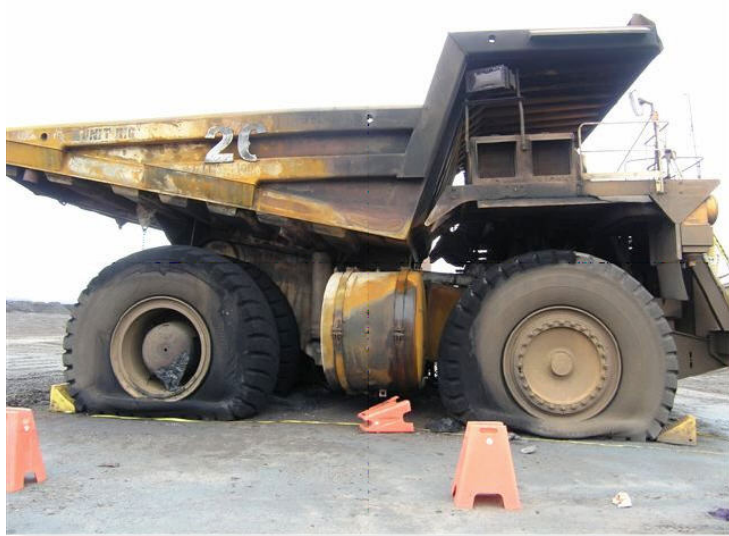
On the surface analyzing fires would appear to be difficult due to the amount of destruction normally involved with these types of catastrophic incidents. Therefore what is needed is a logical approach to uncover the root causes associated with the failure under investigation. What appears to be difficult becomes easy when sound logic with accurate verification of facts quickly lead the investigator through the cause and effect

relationship that led to the undesired and unexpected event – in this case the fire. The PROACT® methodology is perfect for working through this relationship and PROACT® the software package is a great way to document and store the information used to validate the findings of the investigation. To illustrate how PROACT® works to solve these types of failures consider the following example of an incident investigation by one of our clients for a fire that occurred on a hauler truck at a mining operation.

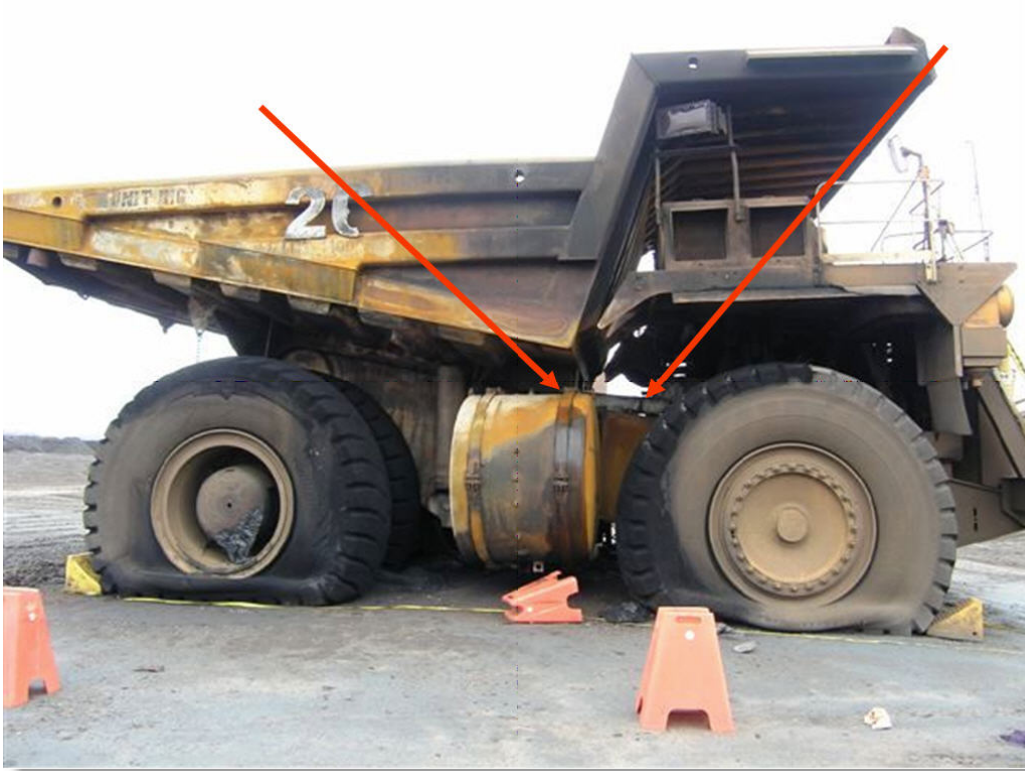
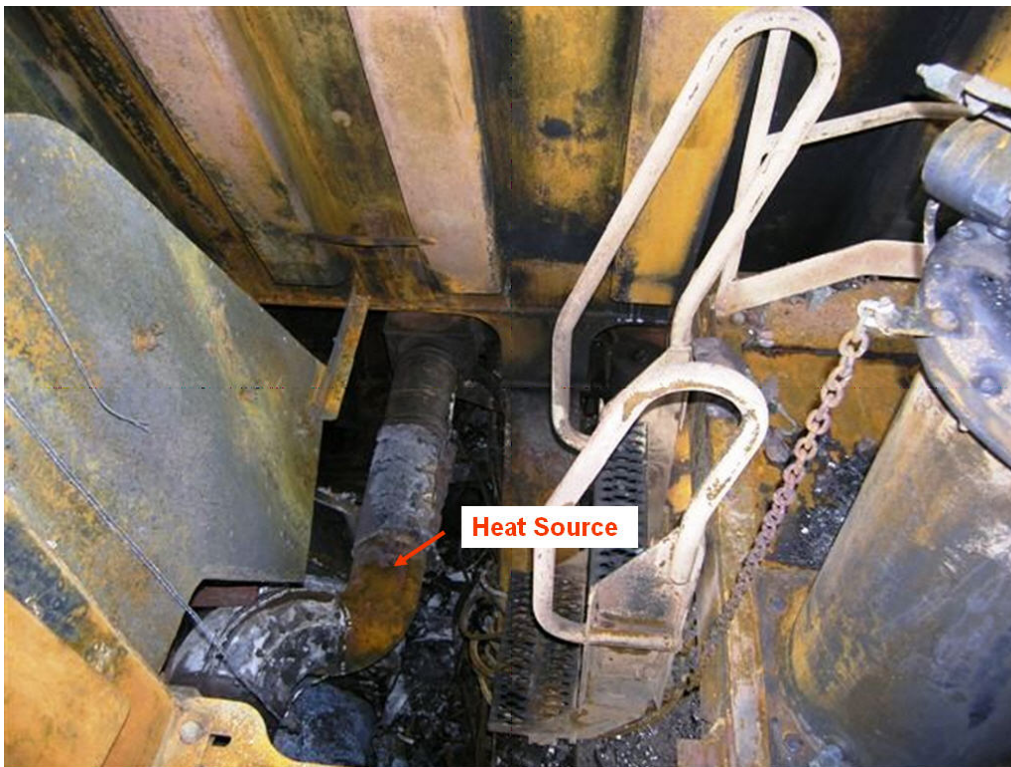
The PROACT<sup>®</sup> methodology teaches analyst to follow the evidence trail in order to uncover cause and inspection of the hauler truck clearly shows the heat path going from the bottom center of the vehicle up towards the cab area. During inspection of the heat

path ash is found on the exhaust piping located in the center lower area of the vehicle. This is clearly the location of the heat source.

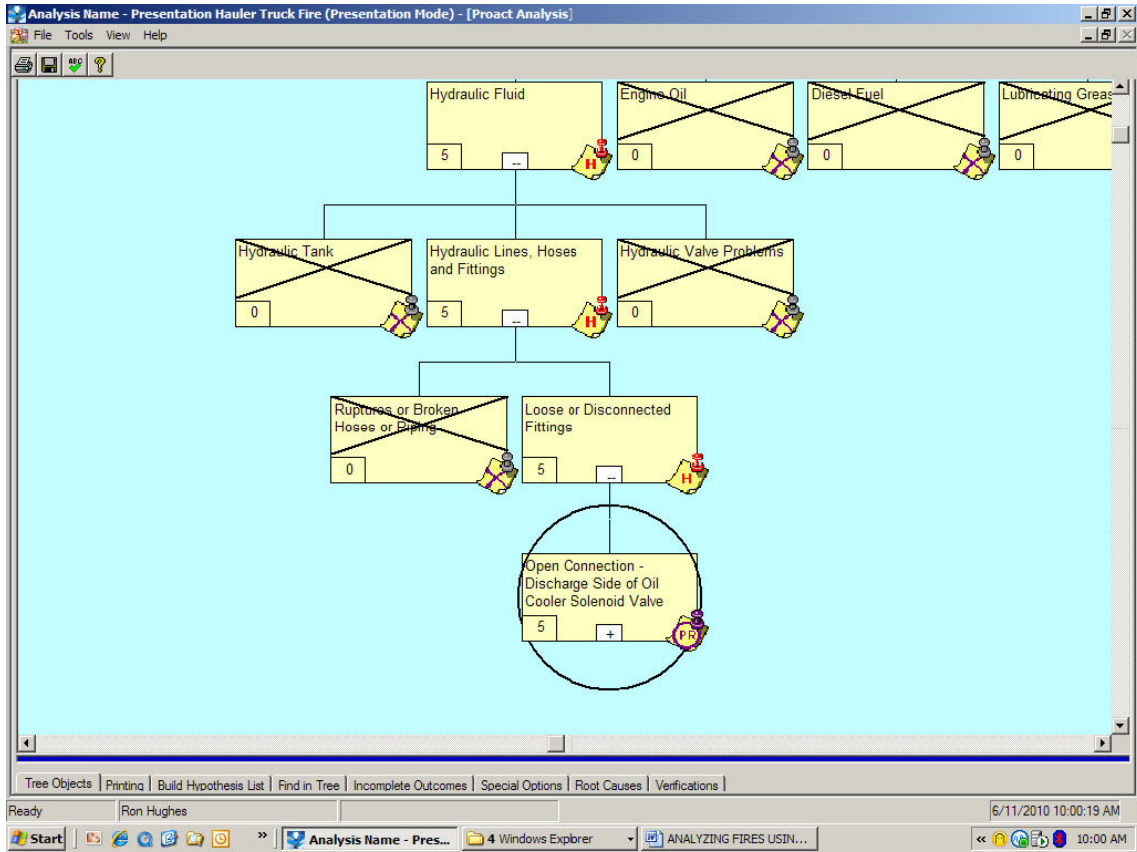
full with the exception of the hydraulic fluid and the diesel fuel which are found to be empty. However, the diesel fuel system has remained intact and the loss of the fuel can be contributed to the extreme heat present during the fire causing the fuel to evaporate. This leads to a more thorough inspection of the hydraulic system. Again following the PROACT<sup>®</sup> methodology and tracing the heat path, the source of the fuel is quickly found to be an open connection of the discharge side of the Oil Cooler Solenoid Valve.

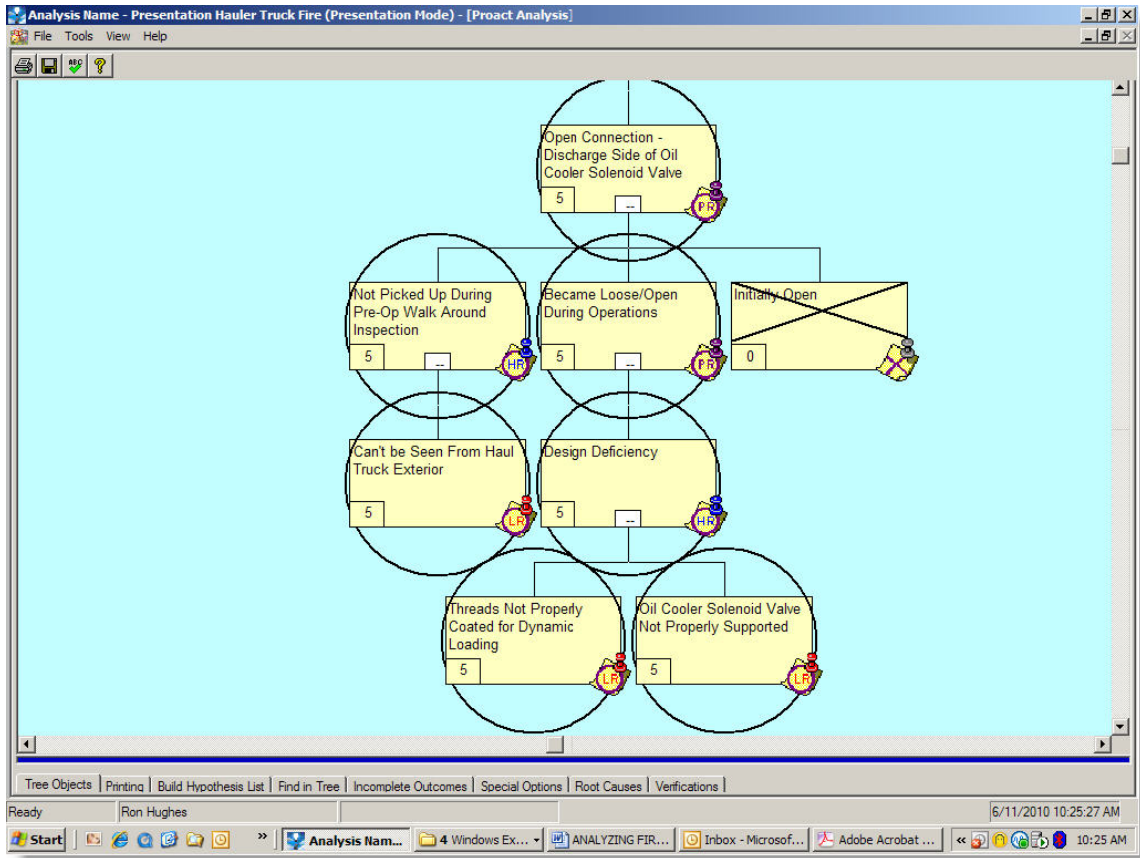
This open connection is the physical thing that if corrected would have prevented or eliminated the incident under investigation (the fire) and therefore is labeled as a physical root cause of the failure. There are three possibilities for this valve connection being open. It was either initially open (which is determined not to be true), not picked up during initial walk around inspection by the operator (found to be true since it can not be seen from outside the vehicle and therefore the human and latent root causes) or became loose during vehicle operations (proved true by the evidence seen on the threaded connection another proven physical root cause).

Continuing to explore how the connection can become loose during operations it is determined by further examination of the threads that the valve had become loose during operations due to a design deficiency (another identified human root). This was due to the fact that the valve was inadequately supported (actually had no support) and that there was no locking or threading lubrication for the connection.

As a result of this analysis the client inspected the rest of his hauler truck fleet for possible similar failure symptoms (leveraged the analysis). Several vehicles received maintenance to prevent this sporadic failure from becoming a chronic problem throughout the fleet.
