JRCICE2007-40042

ROOT CAUSE ANALYSIS INCREASES LOCOMOTIVE RELIABILITY AT AMTRAK

HHP-8 Power Modules

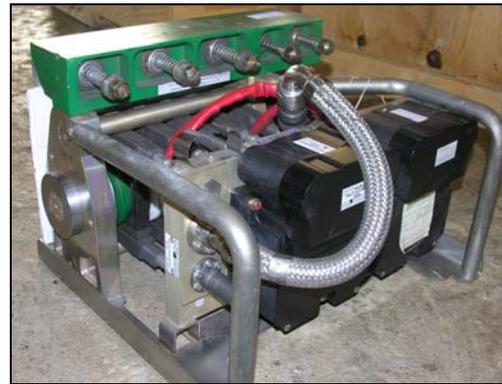
Figure 1: An ECO-B2 Power Module

The HHP-8 locomotive was an AMTRAK asset with such low reliability that the idea of taking the entire fleet out of service was seriously considered. AMTRAK directed the T-Solutions Reliability team to perform an RCA of the HHP-8 power module failures. Figure 1 shows an ECO-B2 power module removed from the locomotive. A Pareto analysis was performed and it was found that of the top twelve systems on an HHP-8, the Power Modules had the highest failure rate as shown in Figure 2. Power module problems originated with the delivery of the HHP-8 locomotive units. It was thought that resolution of this issue alone would bring a substantial positive impact to the reliability of the HHP-8 fleet.

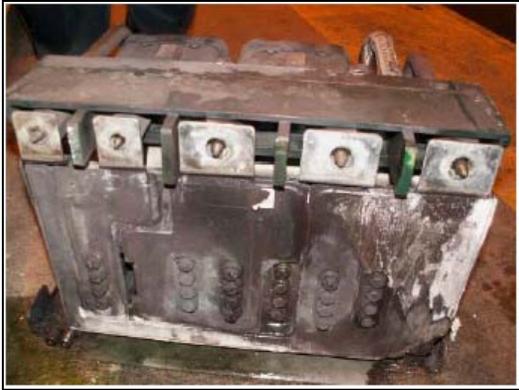
A cross-functional team of AMTRAK personnel coupled with reliability consultants and the original equipment manufacturers was formed to begin the RCA process for the HHP-8 Power Modules. The first failure event investigated by the RCA team occurred on a locomotive that was shopped as a result of a glycol leak in the central propulsion block. The RCA team conducted a visual inspection of locomotive, performed analysis of all onboard monitoring systems recorded data as well as other data gathered from interviews and activities. All failed power modules were sent to the Wilmington Maintenance Facilities Electric Shop, where a thorough teardown inspection was planned. The power modules were replaced the locomotive was tested and inspected and was returned to Service. Subsequently, the locomotive suffered a second glycol leak in Auxiliary Block, which was found during a planned maintenance cycle. Figure 3 shows a failed ECO-B2 power module from the first investigation.

Figure 3: Failed power module

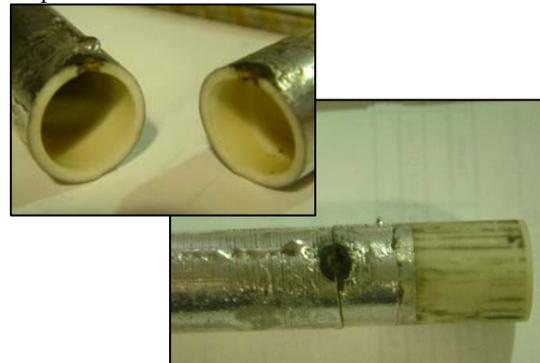
Figure 4: Cooling Device failed Ceramic tube

1. Cooling device – Failure of a cooling device sub component was found to be primarily due to small holes in the ceramic cooling tube wall. These tubes pass through the cooling device body (heat sink) and allow the glycol/ water coolant to draw heat from the device and semiconductors while maintaining an electrical isolation of the coolant. Figure 4 shows a failed ceramic cooling tube that has been

disassembled from the power module. The device body is connected to the 2,750V DC bus. The identified holes result in power module electrical failures from DC link ground faults, producing internal arcing and localized flashing of coolant. Over time this will result in power module mechanical failures in the form of ruptured cooling devices (explosion from flashing in clogged tubes) and coolant leakage into the high voltage power module cabinet. Figure 5 is an image of a ceramic cooling device that is arcing due to pinhole leaks.

1. Continue RCA efforts to determine Cooling device failure root causes
2. Adopt DC ground investigation procedure created for HHP-8 locomotives
3. Replace cooling plate adapters with RCA recommended fittings and Dowty washer
4. Increase the frequency of locomotive systems download and analysis to daily periodicity
5. Establish HHP-8 troubleshooting procedures and protocols to prevent unnecessary damage and maintenance effort

1. Quality assurance of ceramic tubes.
2. Insufficient review and actions taken on control system faults, which resulted in continued operation with HV DC link grounds. The daily Preventive Maintenance procedures have been changed to ensure that maintenance events recorded by the HHP-8 condition monitoring system are downloaded and reviewed daily. This data is used to predict imminent failures and allow for scheduled maintenance to be performed prior to failure.
