# Case History #1: ISPAT Inland, Inc.

East Chicago, IN

**UNDESIRABLE EVENT:** Catastrophic Failure of #4 BOF (Basic Oxygen Furnace)  
Lance Carriage Assembly in the Steel Making Area.

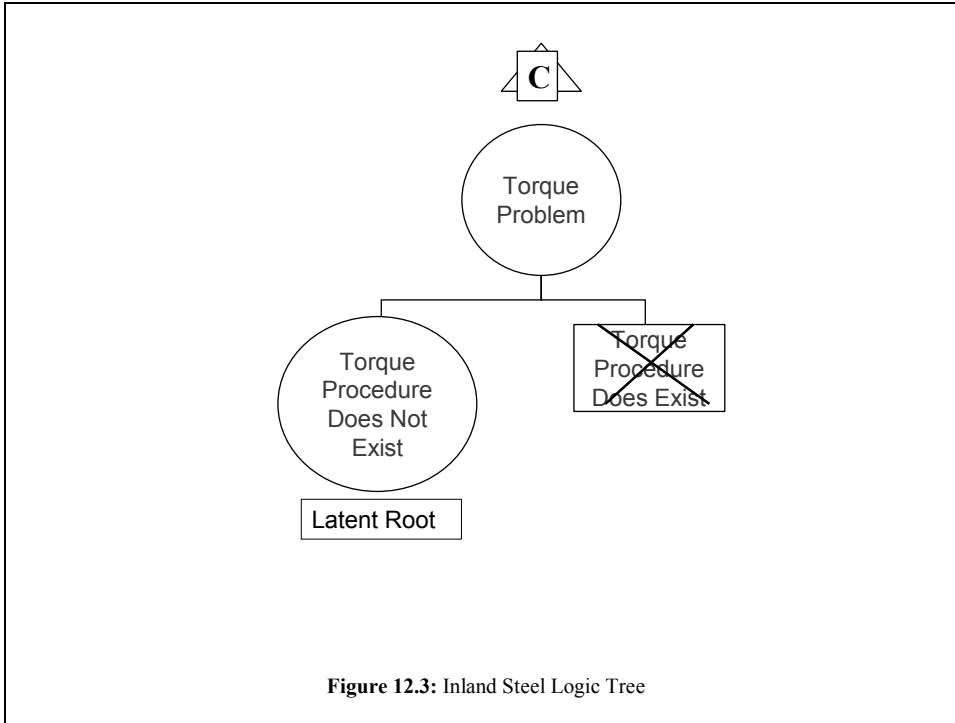
Figure 12.3: Inland Steel Logic Tree

- Excessive Vibration
- Insufficient Motor Movement Prevents Proper Alignment
- Improper Gear Mesh
- Wrong Hug Nut Installed on Brake Pull Rod
- Debris Under Sheave Plate Could Have Prevented Movement
- Dirt/Graphite Not Cleaned Out
- Current Design Allows Dirt to Accumulate

- Unacceptable Conditions Not Observed During Field Inspections
- Severe Misalignment
- Field Inspection Error
- Aware of Unacceptable Conditions, But Not Responded To
- Current Safety Dog System Design Inadequate
